NOTICE OF REGULAR MEETING
DELTA COUNTY COMMISSIONERS COURT

This report fulfills the Texas Historical Commission's requirements outlined in the "Recommended Outline for a Courthouse Preservation Master Plan".

Summary of Existing Conditions & Recommendations

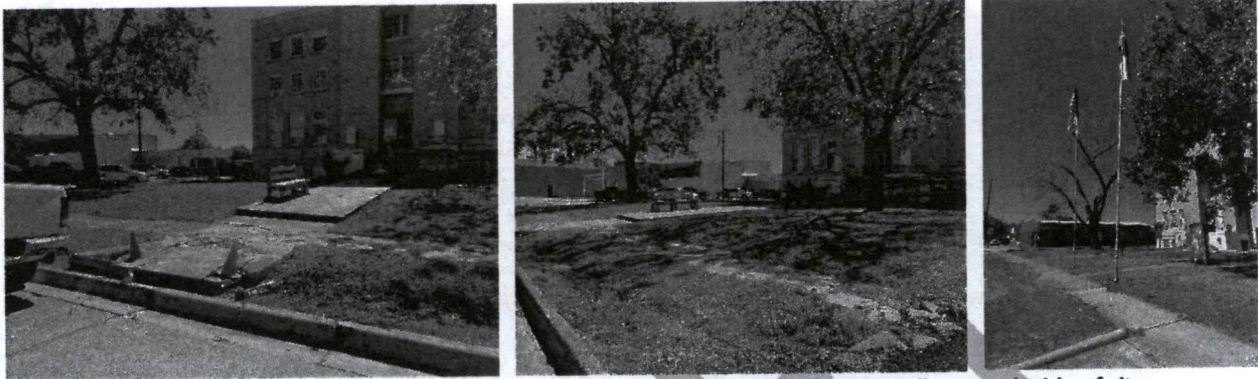
The existing sidewalks appear to be in their original locations as illustrated by the historic photographs. Their condition ranges from fair to severe. The sidewalks in the worst condition are at the north side of the site parallel to the street. The entire length of the sidewalk is cracked and deteriorated to the point that the grass is taking over the pavement. The County has placed cones to warn people from using the curb step.

Left: Cones at north curb. Center: Example of severely deteriorated sidewalk at north side of site. Right: Fair condition sidewalk at south edge of site.

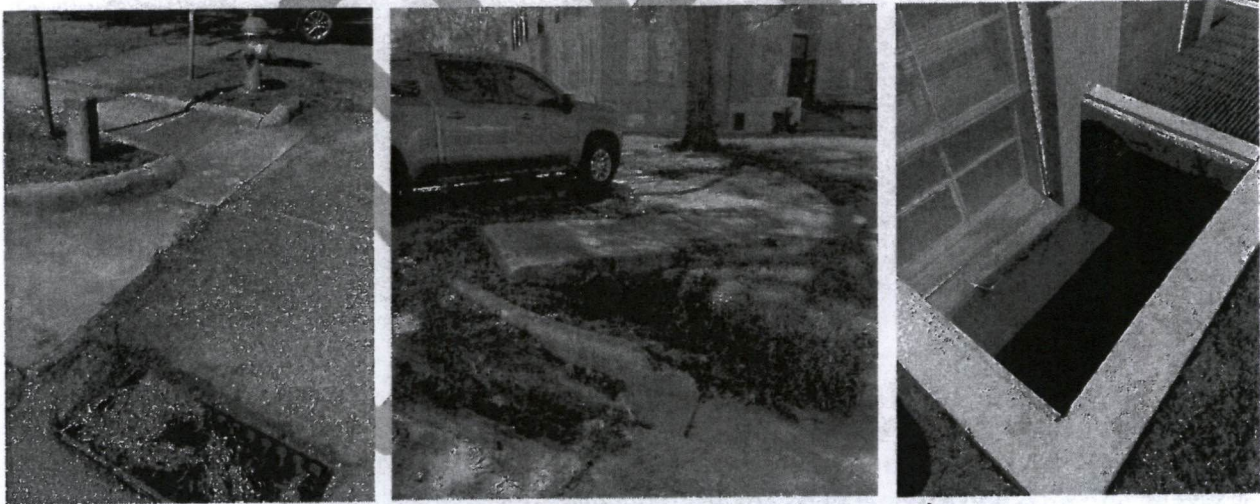
The site has limited storm drains. One small grate is visible at the southeast corner at the intersection of N.W. Second Street and W. Dallas Avenue. It was covered with debris during the assessment. A small culvert runs under the sidewalk at the northeast corner of the site. The concrete is cracked, deteriorated, and in poor condition. The adjacent ditch is not sufficient. In general, the turf areas appear to drain away from the building. A civil engineer should confirm during construction document development. Standing water was visible in some of the areaways along the building's perimeter. The building's downspouts are internal. Lamb's tongues or curb outlets are not present, so the path of downspout drainage is unclear. Komatsu assumes the internal downspouts drain at a sub-grade sewer line. This should be confirmed in a later phase.

Left: Stormwater grate at southeast corner. Center: Culvert at northeast corner. Right: Example of standing water in areaway.

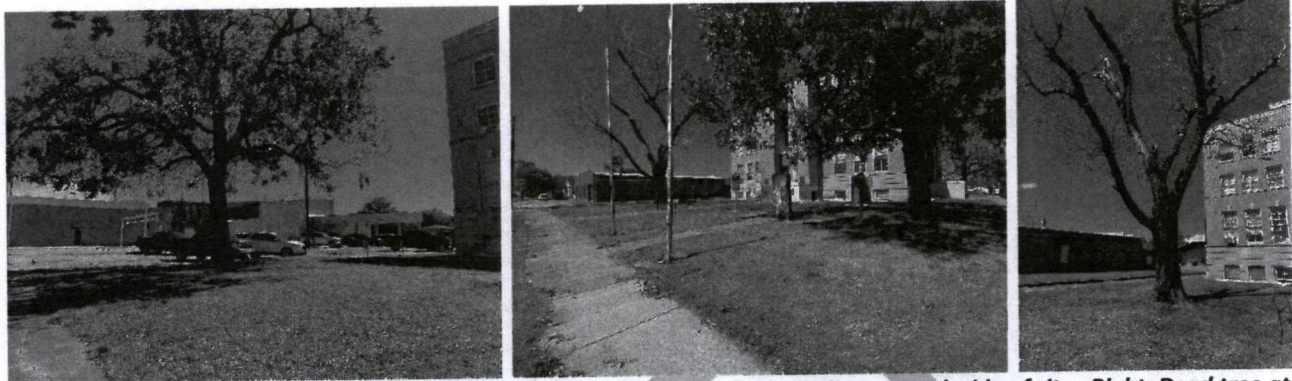
tree at the southwest corner of the site is dead. It should be removed. The stump of a previously removed tree is present at the southeast side of the site. The other major trees are in fair condition. The lawn is in fair condition. The shrubs and other plantings have been removed.

Left: Example of vegetation at north side of site. Center: Example of vegetation at south side of site. Right: Dead tree at southwest corner.

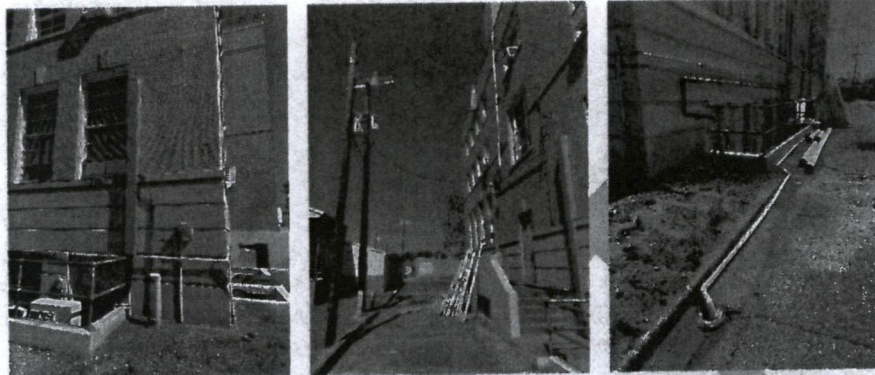
Left: Example of mini split cassette at areaway and intrusive exterior conduit covering. Center: Overhead powerlines entering building at west elevation. Right: Exposed water supply at west elevation entering boiler room.

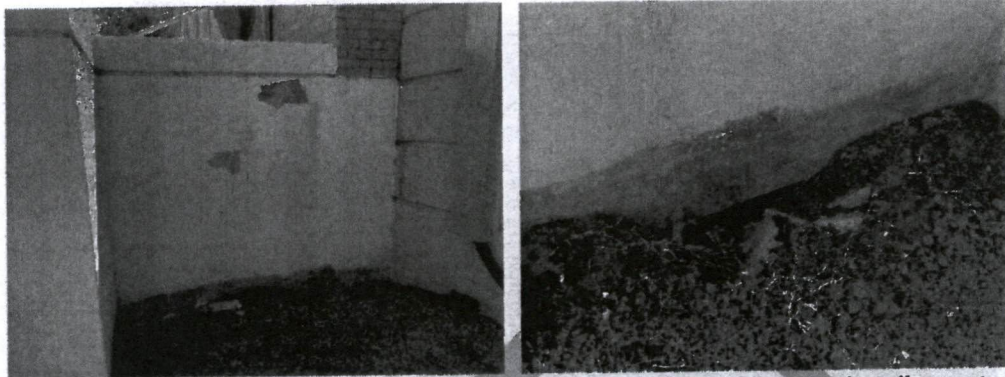
Komatsu noted that the soil has settled around the perimeter of the building. This is noted by the paint line at the masonry. This condition was noted at all elevations but appeared to be the most severe at the east and north facades.

Left: Soil settling near east entrance. Right: Close up of paint line and void below porch wall at east entrance.

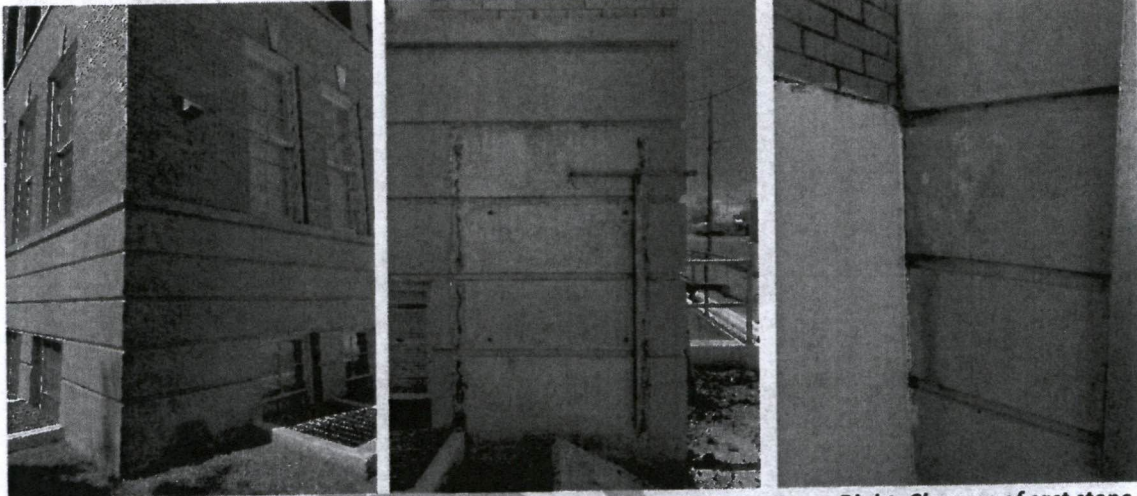
Left: Example of tan cast stone base. Center: Green coating at northwest corner. Right: Close up of cast stone with failing coatings.

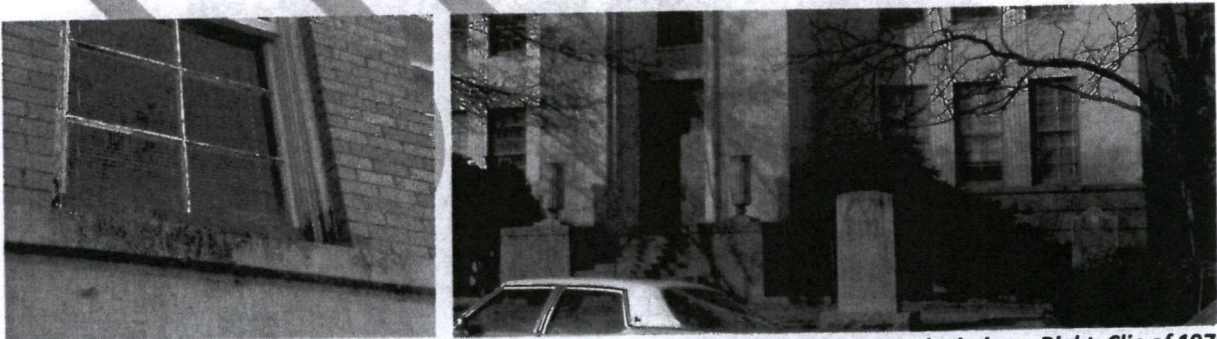
Left: Example of failing paint and biological growth at cast stone sill below deteriorated window. Right: Clip of 1975 photograph showing cast stone base painted green.

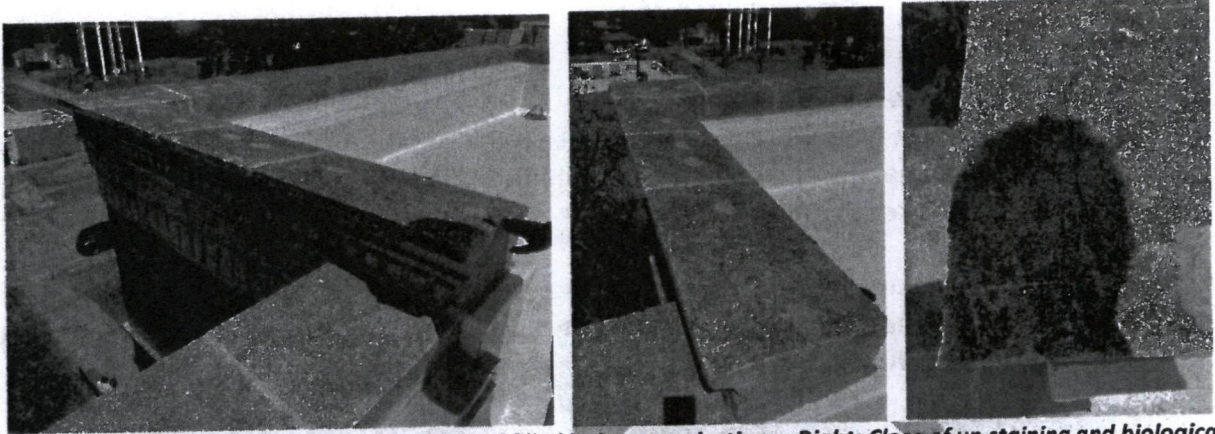
entrance. Mechanical breakage is also visible along the skyward edge of the cornice line. This deficiency is minimal and is typically caused by hail or other precipitation. In general, the cast stone elements are in fair condition.

Left: View of cornice from roof. Center: View of holes at projections. Right: Close up staining and biological growth at cornice skyward surface.

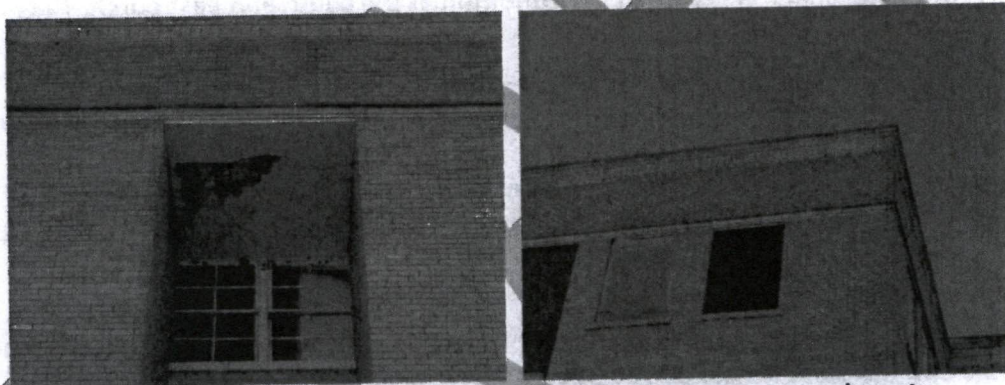
Left: Paint peeling at north vault soffit. Right: Staining at cast stone elements.

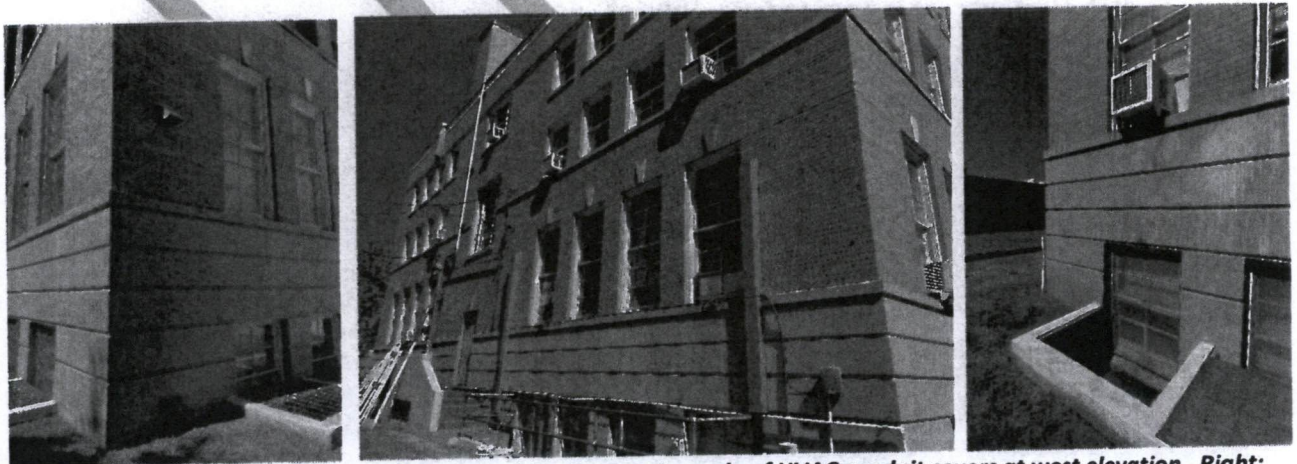
Left: Mini split view with visible condensate drip. Center: Example of HVAC conduit covers at west elevation. Right: Example of window unit with visible condensate drip.

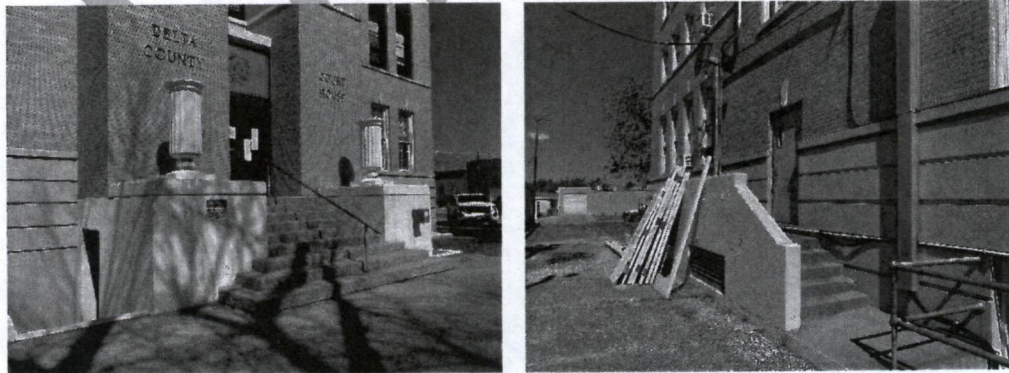
The west entrance is simpler in design. The concrete steps are stained from general use. The cheek wall is painted and the paint is flaking. The handrails are all uncoated galvanized pipe steel. They do not appear to meet current TAS requirements. The fasteners are corroded and rusting. The west entrance porch elements are in poor to fair condition.

Left: South Entry Porch. Right: West Entrance.

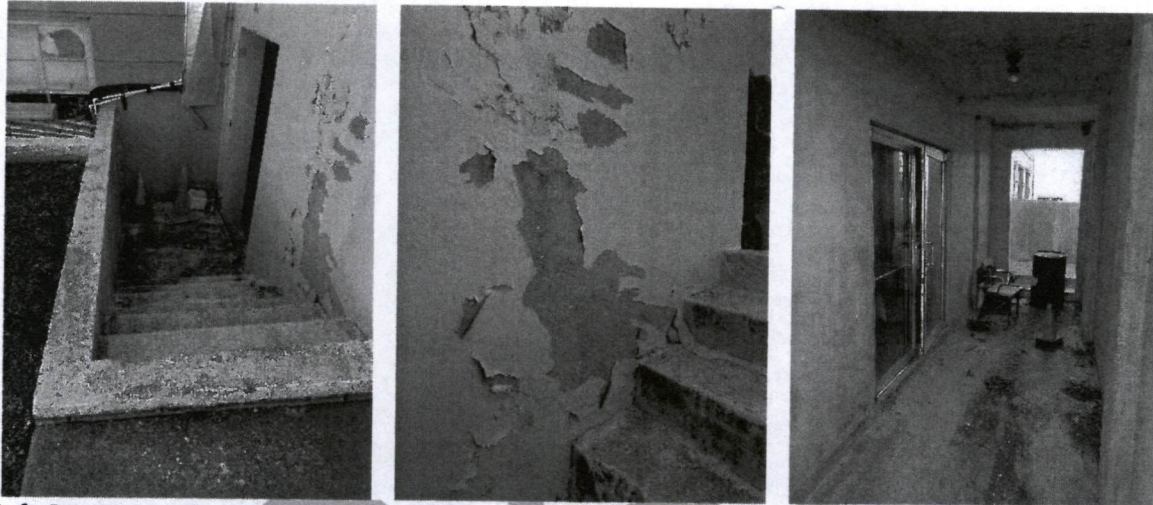
Left: Basement stairs at northeast side. Center: Severe paint peeling at porch wall adjacent to basement stair. Right: View of north basement vestibule.

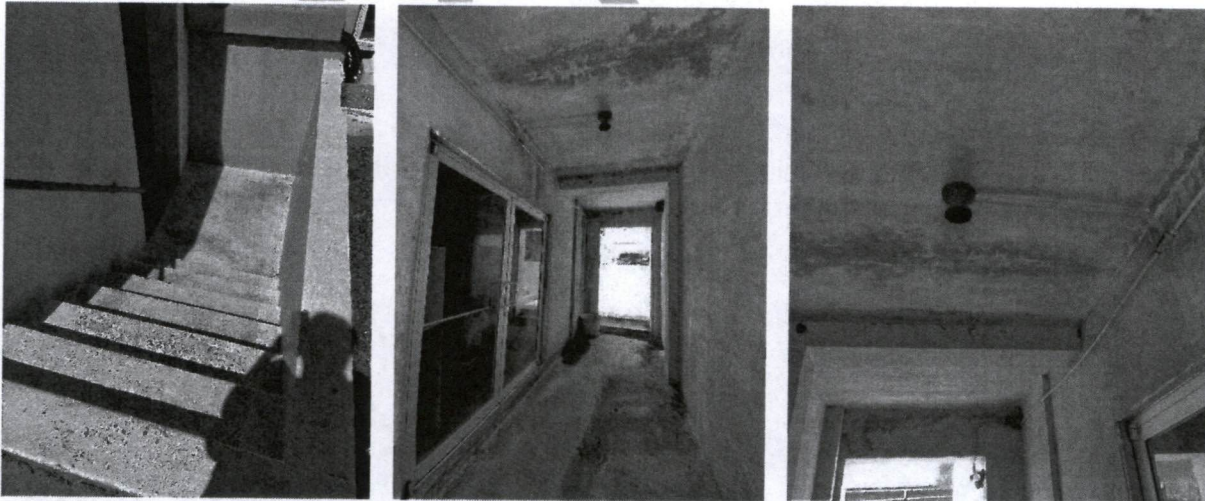
Left: Basement stairs on the southeast side. Center: View of south basement vestibule. Right: Example of rusted light fitter.

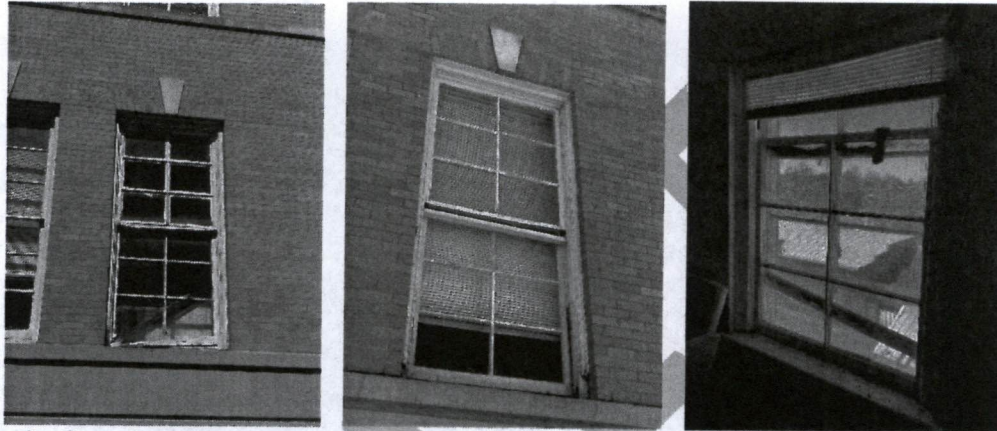
Left: Example of wood window in severe condition at south elevation. Center: Example of wood window in severe condition at north elevation. Right: Example of wood window in severe condition from third floor interior.

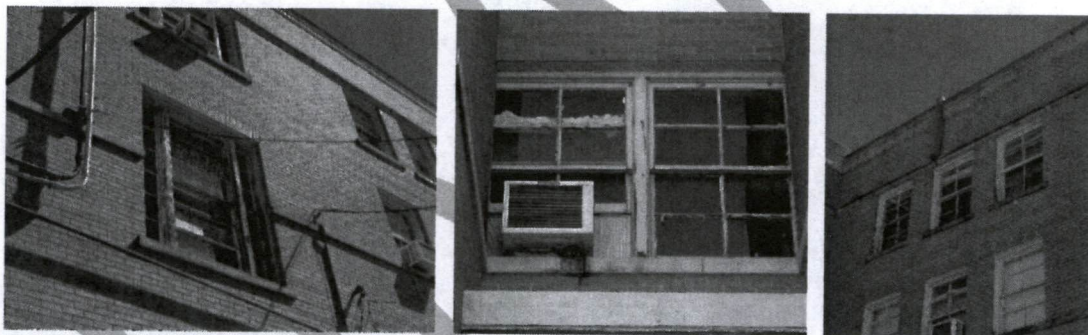
Left: Wood window in severe condition above west door. Center: Example of intrusive window unit. Right: Wood windows in severe condition with intrusive HVAC modifications.

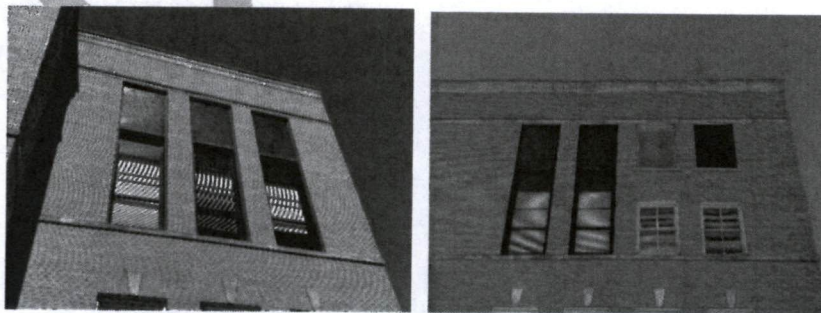
Left: Example of replacement windows at south elevation. Right: Example of replacement windows and missing windows at east elevation.

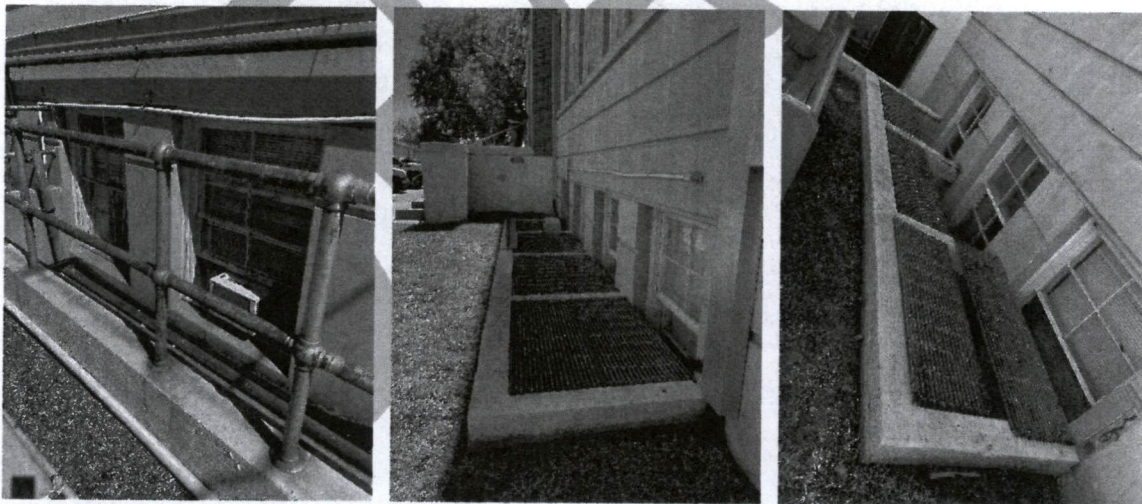
Left: Closeup view of corrosion and rust at pipe railing. Center: View of east side areaway. Right: View of north side areaway.

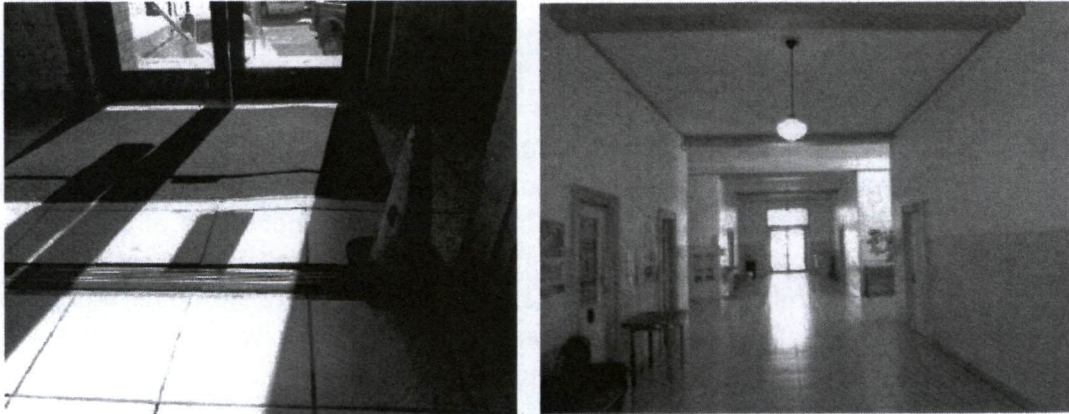
Photos of corridor floor tile that has been removed. Courtesy of Randall Scott Architects.

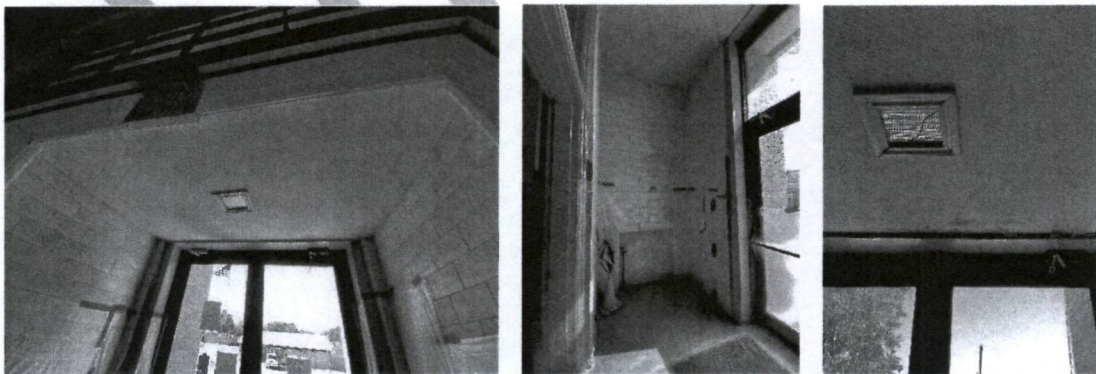
Left: Example of vestibule ceiling. Center: Example of vestibule wall with tile wainscot and radiator recess. Right: Close up view of north vestibule ceiling with crack in light fixture and damage at door lintel.

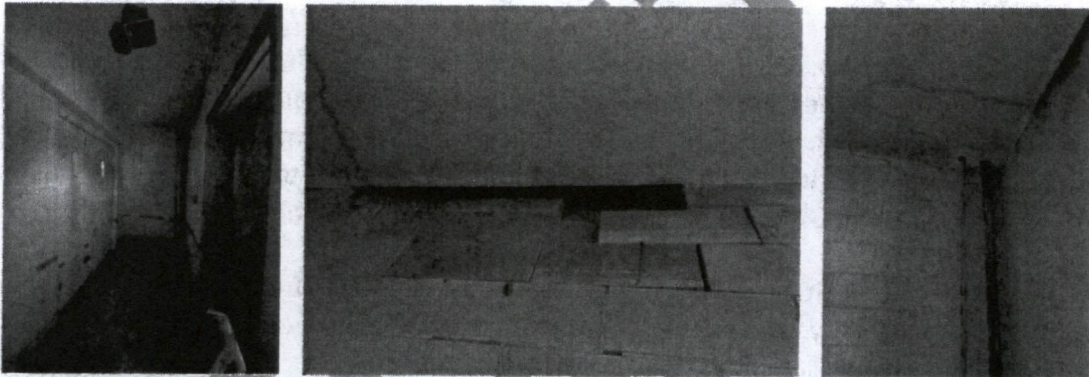
Left: View of west vestibule looking south. Center: Loose tile. Right: Water stain at ceiling with intrusive piping.

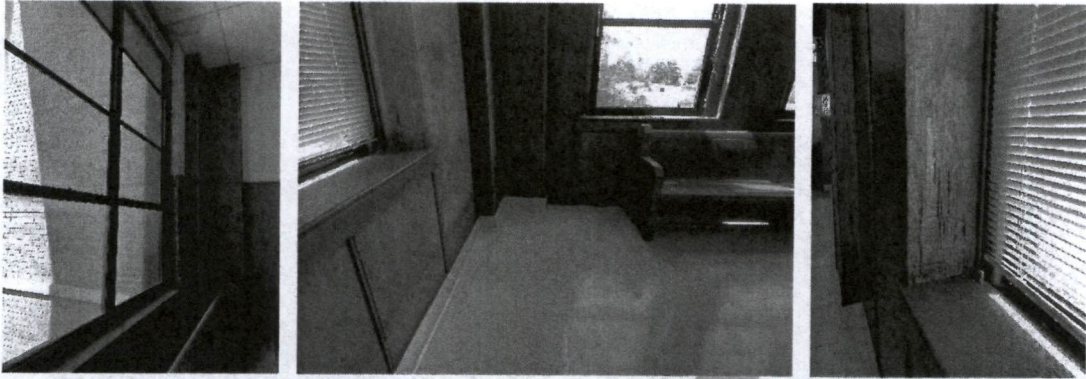
Left: Example of replacement windows at District Courtroom. Center: Example of platform shadow at southeast corner. Right: example of severe veneer failure at window.

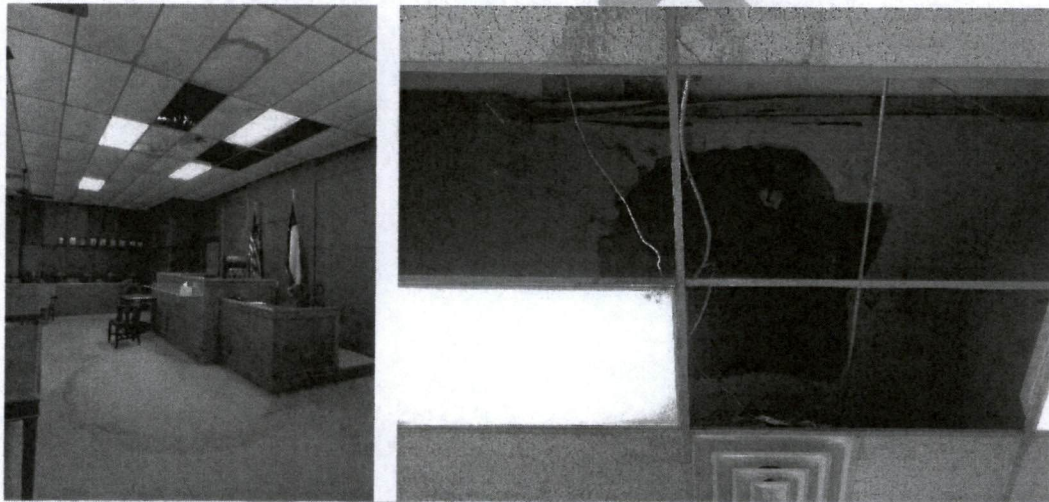
Left: Water damage at Judge's Bench. Right: View of plaster ceiling damage above grid ceiling.

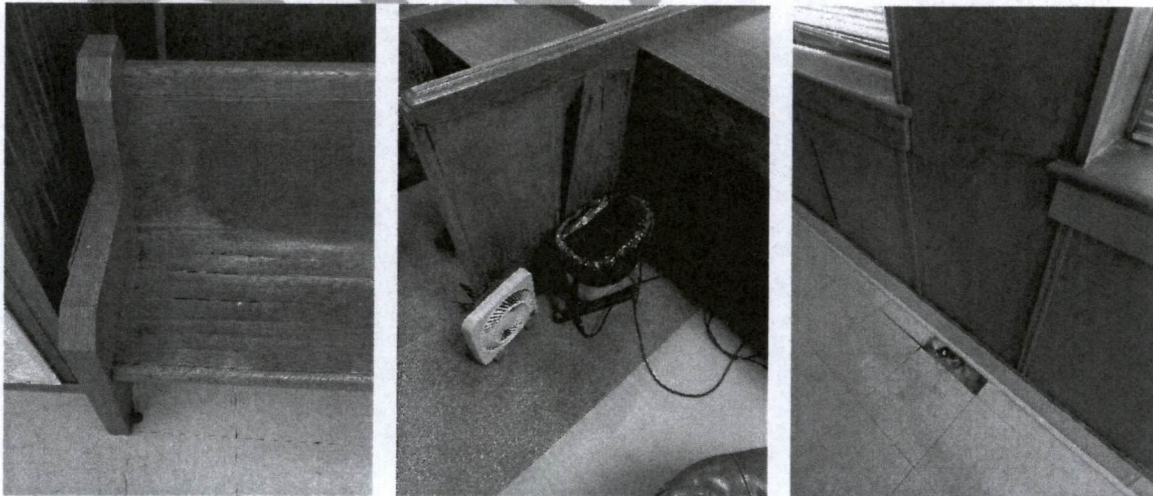
Left: Example of veneer damage at gallery bench. Center: View of veneer damage at Judge's Bench. Right: Example of missing floor tile at remove radiator pipe.

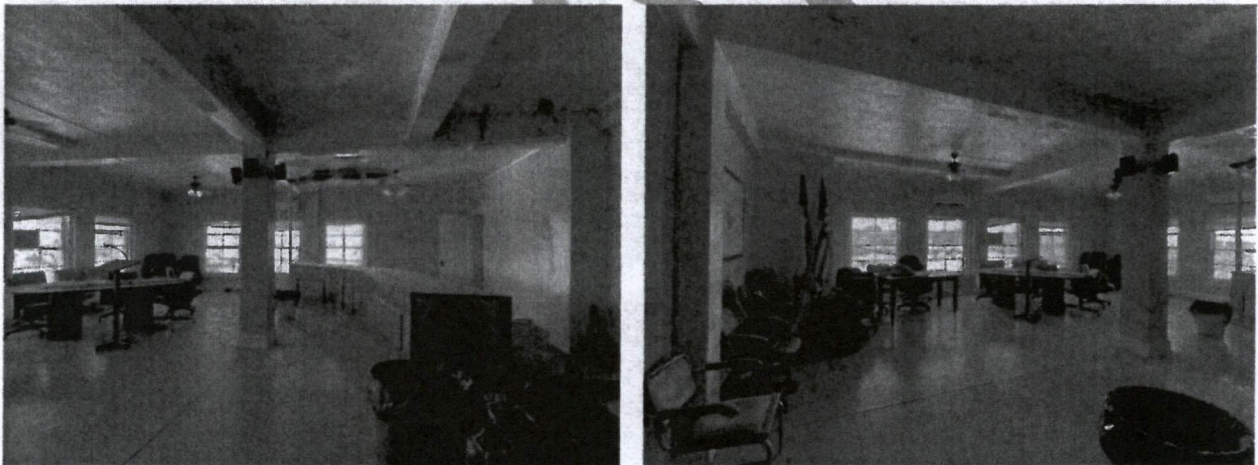
Mini split HVAC units have been added to the west and north walls. The Commissioners Court Dias is a complete loss. The roof leaks has caused severe water damage at all sides of the Dias.

Left: View of County Courtroom looking north. Right: View of County Courtroom looking west.

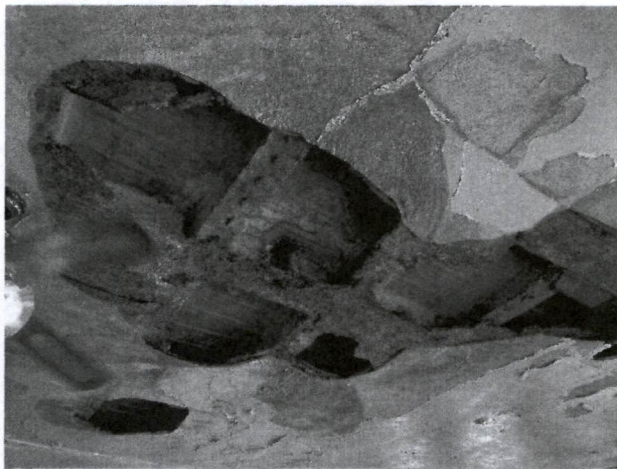
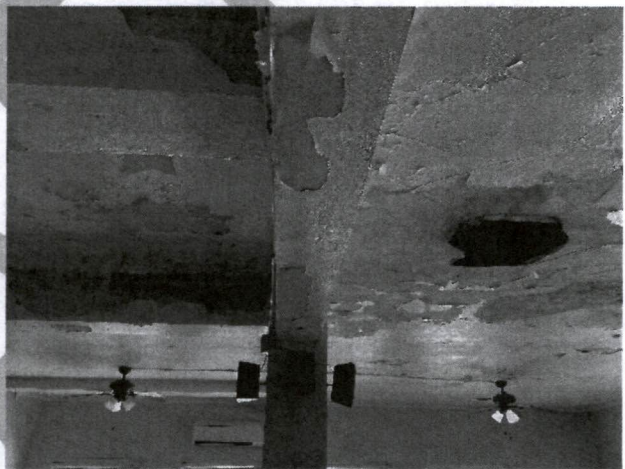
Left: Close up view of damaged plaster ceiling and concrete roof deck. Right: View of central beam with differing roof structures at either side.
