NOTICE OF REGULAR MEETING
DELTA COUNTY COMMISSIONERS COURT

This report fulfills the Texas Historical Commission's requirements outlined in the "Recommended Outline for a Courthouse Preservation Master Plan".

Summary of Existing Conditions & Recommendations

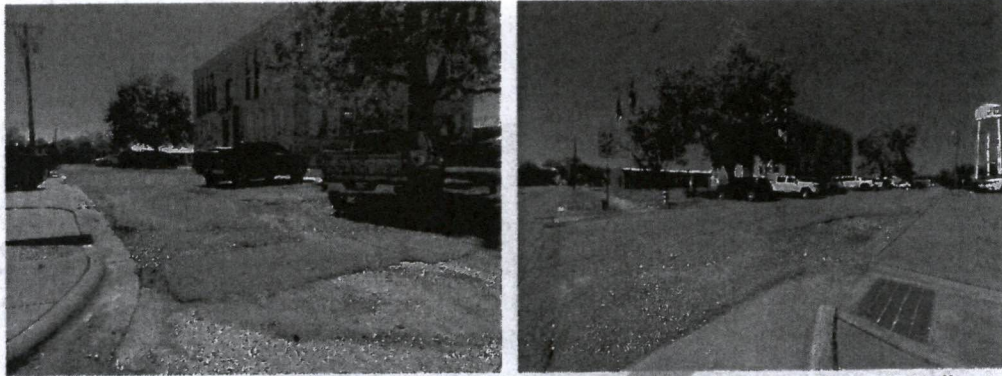
The primary parking area is located along NW 2nd Street. It is technically street parking, which makes it in the City's right-of-way. The parking spaces closest to the building are not striped. The paving is a mixture of asphalt, gravel, and concrete that is uneven and in severe condition. The accessible spaces are marked by signage; however, the spaces are not demarcated, and the paving does not meet TAS requirements. The County is currently working with the City of Cooper to replace the parking area paving.

Left: View of parking area from W. Bonham Avenue. Right: View of parking area from W. Dallas Avenue.

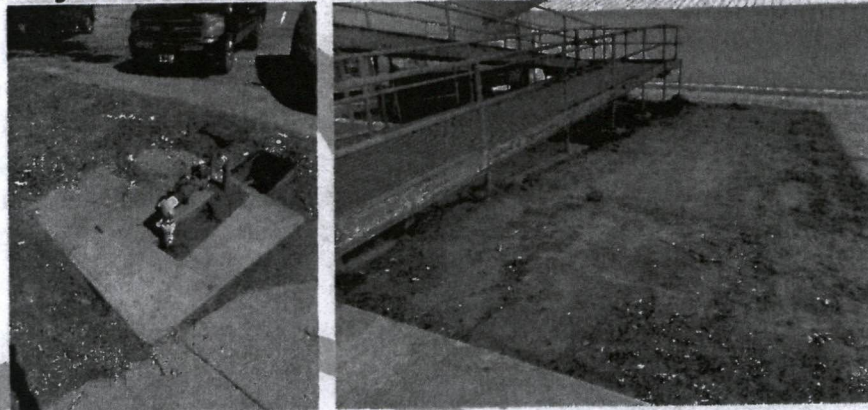
Left: Water main, note new PVC. Center: Saturated soil at northwest side of Square.

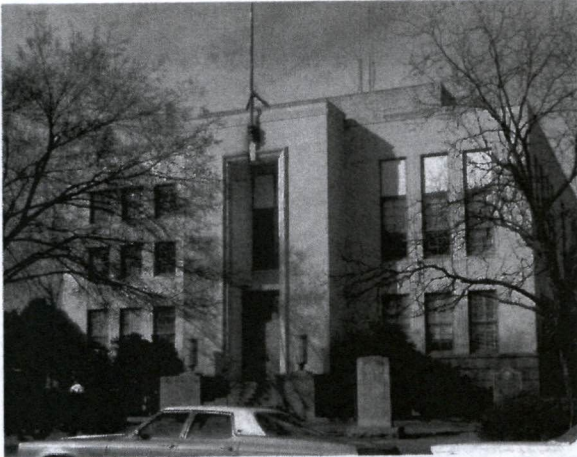
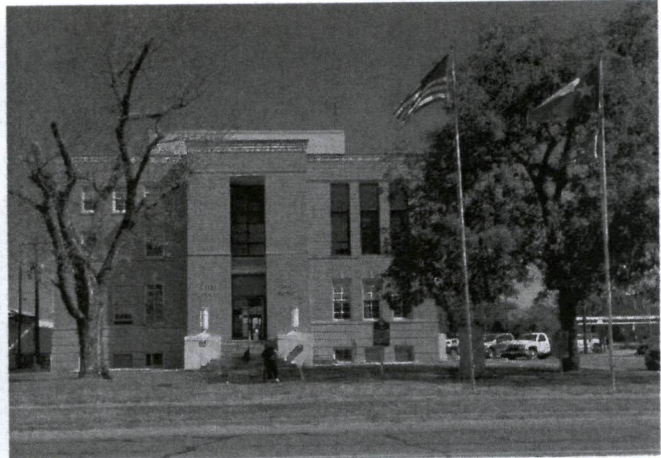
Originally, the Courthouse had flagpoles attached to the north and south elevations above the central vault openings. These flags were removed when the building was re clad in 1977/1978. There are currently two flagpoles adjacent to the southernmost sidewalk and they are in fair condition. They were erected as part of the United States Bicentennial celebration in 1975.

Left: Historic photo of courthouse from 1975 illustrating surface mounted flagpole. Note significant rust stains around the flagpole mount. Source: Historical Collection (U0663), University of North Texas Special Collections. Portal to Texas History. Right: View of current flagpoles at south lawn.

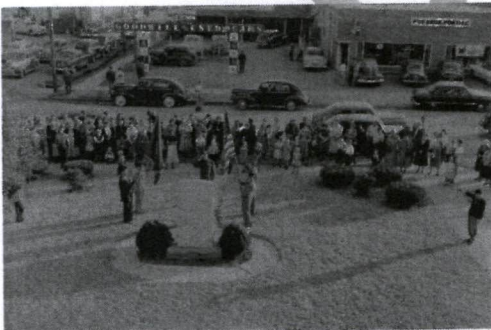
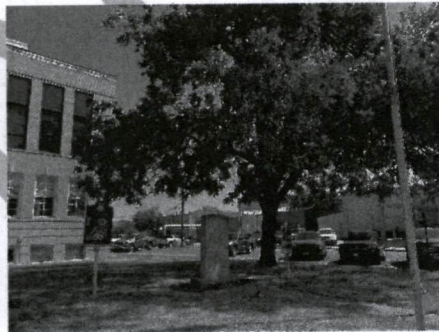
Four monuments and markers are present at the southeast corner of the site. The markers and monuments were added throughout the Courthouse's lifespan, as is typical with a Courthouse Square. The historical markers honor Nathaniel L. Corbet and the Texas Livery Stable. The large stone monument honors local veterans. The small concrete marker at the corner of W. Second and W. Dallas is a survey marker for Texas State Highway 24 Business. The locations of each are marked on the Assessment Site Plan. In general, the monuments / markers are in good condition and can be maintained during a future restoration.

Left: VFW Memorial Dedication on south lawn, circa 1947. Source: Delta County Historical Commission. Center: Photo of extant historical markers and Veteran's Memorial at southeast side of lawn. Right: Texas State Highway Survey Marker.

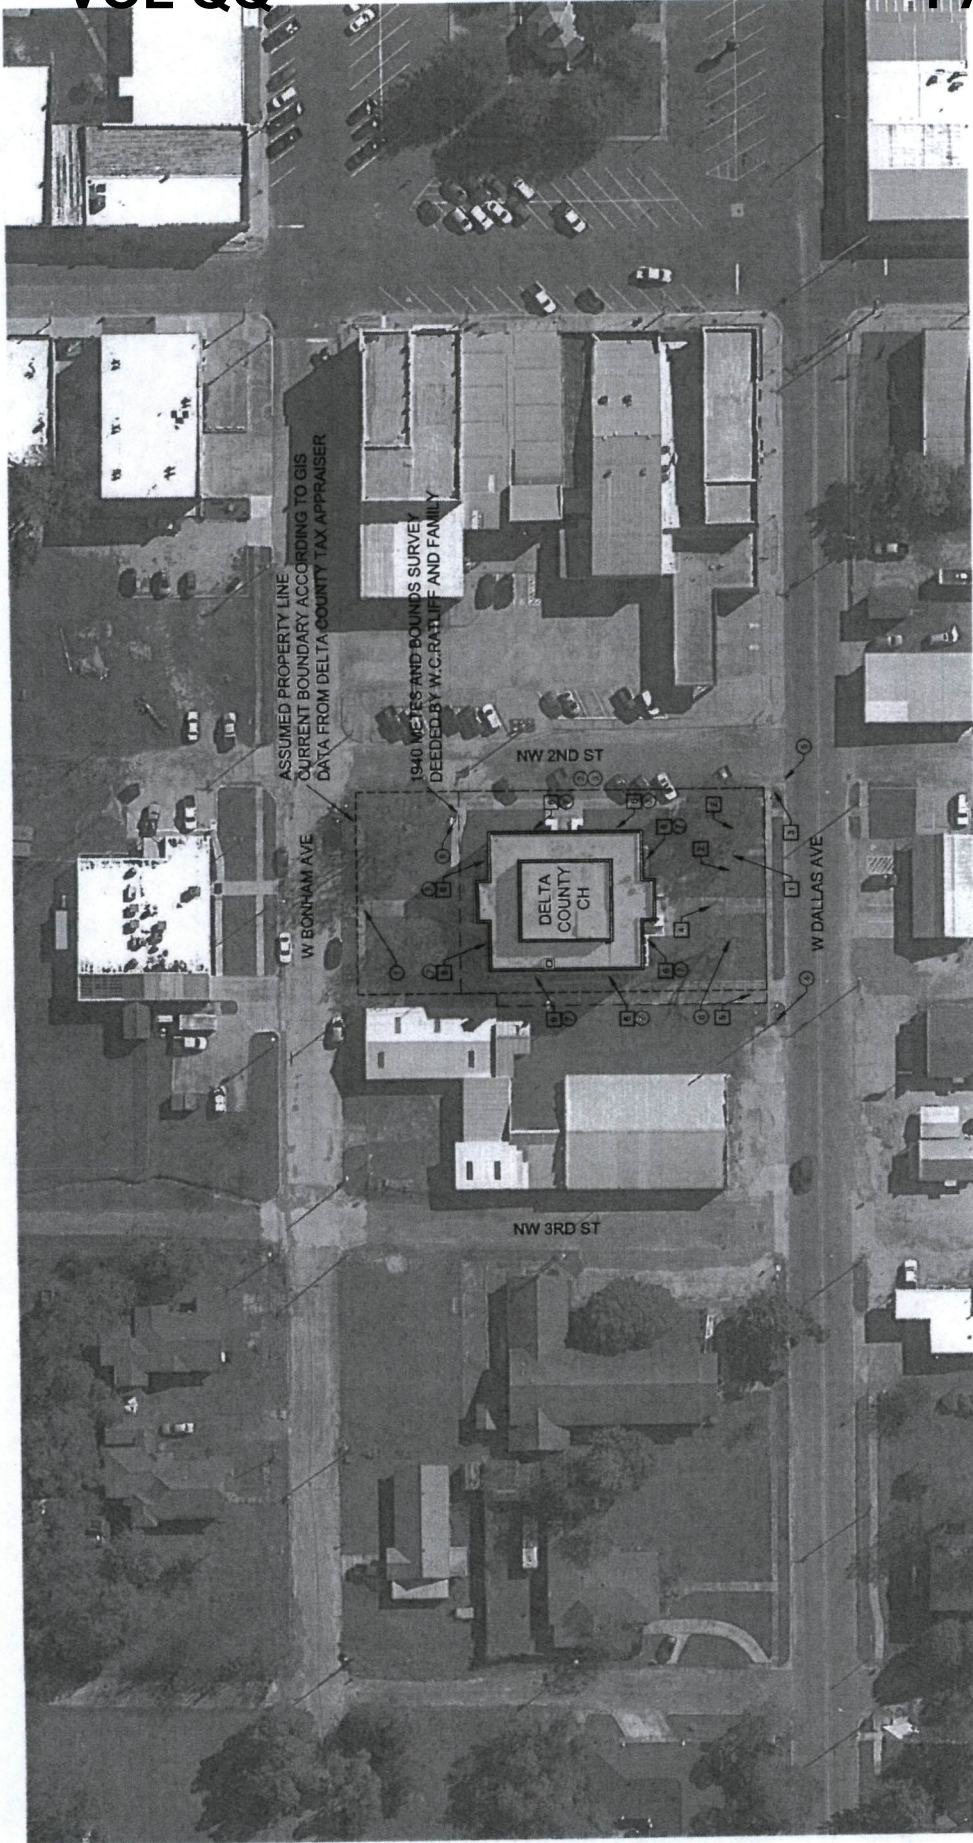
1. DETERIORATED SIDEWALK, TYP.
2. PARKING LACKS STRIPES AND CORRECT DESIGNATION OF ACCESSIBLE SPACES
3. PARKING LOT PAVING IS VERY DETERIORATED
4. INADEQUATE SITE LIGHTING
5. INADEQUATE SITE DRAINAGE, TYP.
6. DEAD TREE
7. AREAWAYS WITH DEFICIENT DRAINAGE
8. INTRUSIVE WATER BACK FLOW VALVE

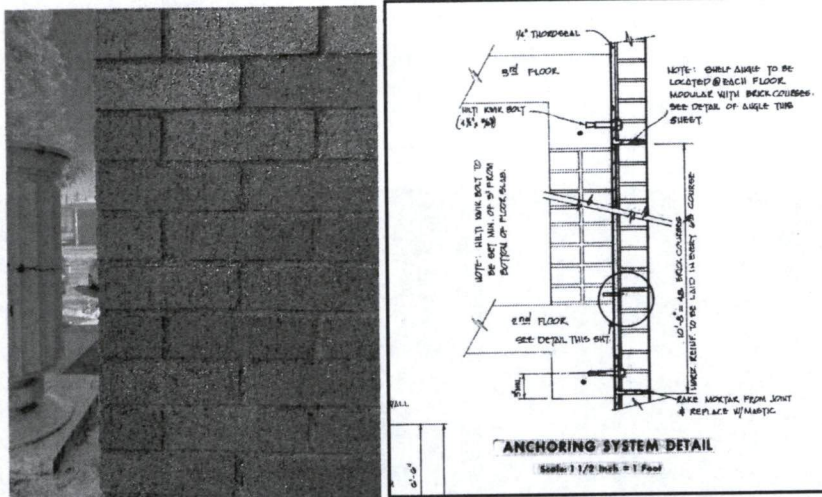
The brick is in fair to good condition. The surface is smooth and uniform. Staining, biological growth, and other defects do not appear to plague the brick at the south, east, and west facades. Slight staining is visible at the north elevation. Biological growth is also prevalent at mortar joints throughout the north façade. In general, the mortar joints are intact and in fair condition at all façades. The most

significant deficiency at the brick is where HVAC conduits have been surface-mounted and penetrated the façade. This mechanical damage will require repair upon restoration. The condition of the masonry anchoring should be explored in more detail through exploratory demolition. Based on the 1970s drawings, the brick is a veneer held up by steel angles. The detail calls for “Thoroseal” water proofing, but a drying cavity and weep holes are not present. By modern standards, this system does not allow for drying and could potentially cause corrosion at the steel members.

Left: Example of brick condition at north elevation. Right: 1978 Anchoring Detail

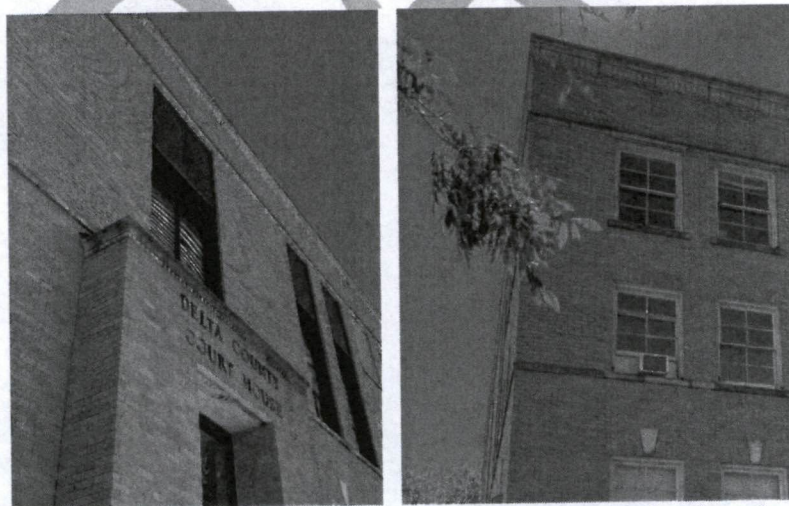
Left: View of cast stone details at east elevation. Right: View of cast stone details at the north elevation.

The Cast Stone Decorative Elements include a belt course below the second-floor windows, a second belt course above the third-floor windows, windowsills, keystones above the first-floor windows, and the cornice. The masonry units are intact, and most mortar joints appear intact. Dark staining and biological growth are present at each element type and at all facades typically at the skyward edge. This is expected for cast stone of this age and is typically caused by pollution in the atmosphere and/or the humid climate. These deficiencies are the most severe at the north elevation and above the east

entrance. Mechanical breakage is also visible along the skyward edge of the cornice line. This deficiency is minimal and is typically caused by hail or other precipitation. In general, the cast stone elements are in fair condition.

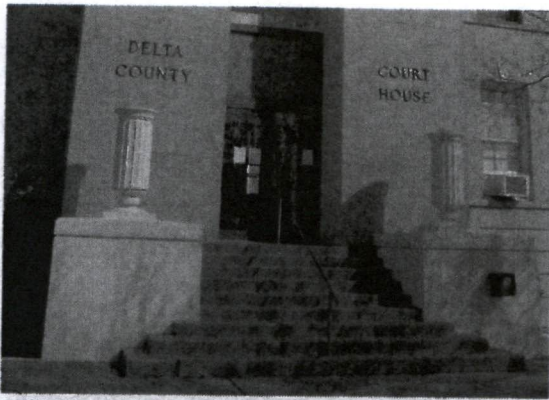
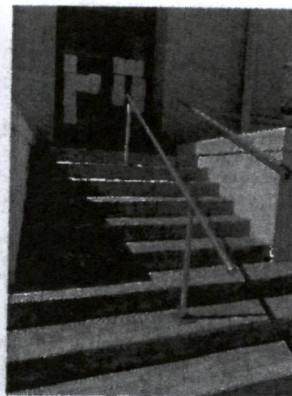
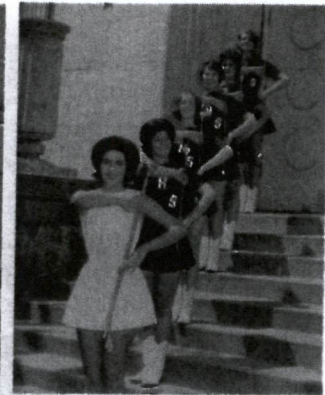
An intrusive cementitious coating has been applied to the risers and treads of the east and south stairs with a faux wood appearance. Older photos show a deteriorated tile finish that appears to have been removed. The original finish was brushed concrete.

Left: View of deteriorated tile at steps that has been removed. Date unknown. Center: View of current intrusive cementitious coating at the east entrance. Right: Historic photograph of Courthouse steps showing brushed concrete finish.

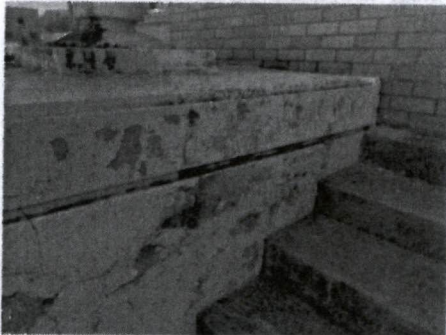
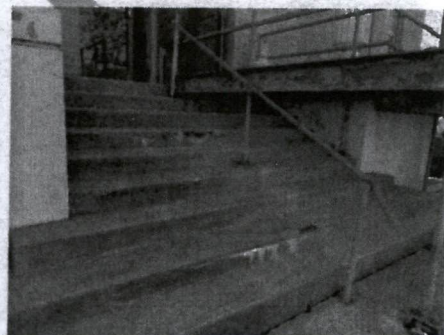
All cheek walls are board-formed concrete that has been painted. Like the cast stone base of the building, it is unclear if the original design intent included a coating or pigmentation for the concrete. The concrete steps and cheek walls are in fair condition at the south and east porch. The north entrance has significant cracking and spalls. It is in poor condition. A major crack extends from the level of the steps up the northeast cheek wall and through the concrete planter. The paint coating is in severe condition at the north porch. Biological growth is present where the paint has peeled off.

The north and south entrances have concrete planters on either side. The south facing planters are in fair condition. Cracks that have been coated over are visible. The north facing planters are in poor condition due to significant cracking.

Left: Peeling paint and cracking at the northeast cheek wall. Center: Northeast planter with significant cracking. Right: View of cracked and spalling concrete at the north steps with white efflorescence.

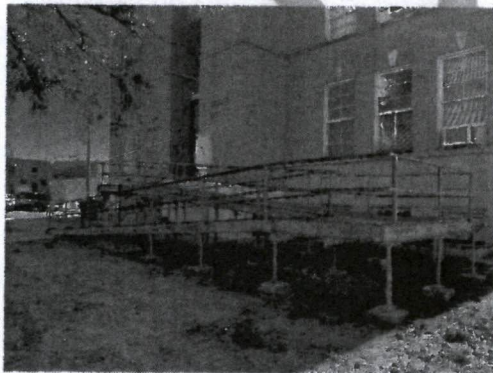
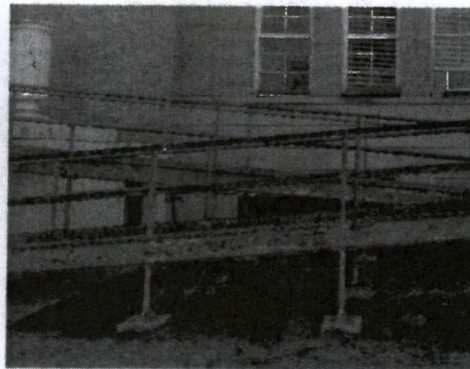
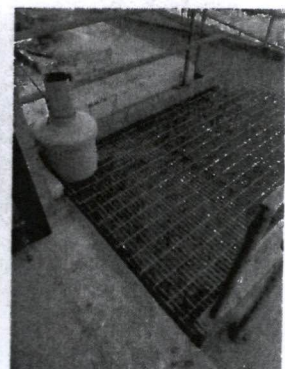
An accessible ramp has been added to the north entrance. It is metal construction on isolated concrete footings. The paint coating has failed. Rust and corrosion are visible at all metal connections and joints. The walking surface is grated. Overall, the ramp appears to be unstable and in poor condition. It does not appear to meet TAS requirements completely. The clear space between the top of the ramp and the entry door is insufficient.

Left: View of the accessible ramp at the north entrance. Center: Close up of deteriorated finish at ramp. Right: Example of ramp walking surface.

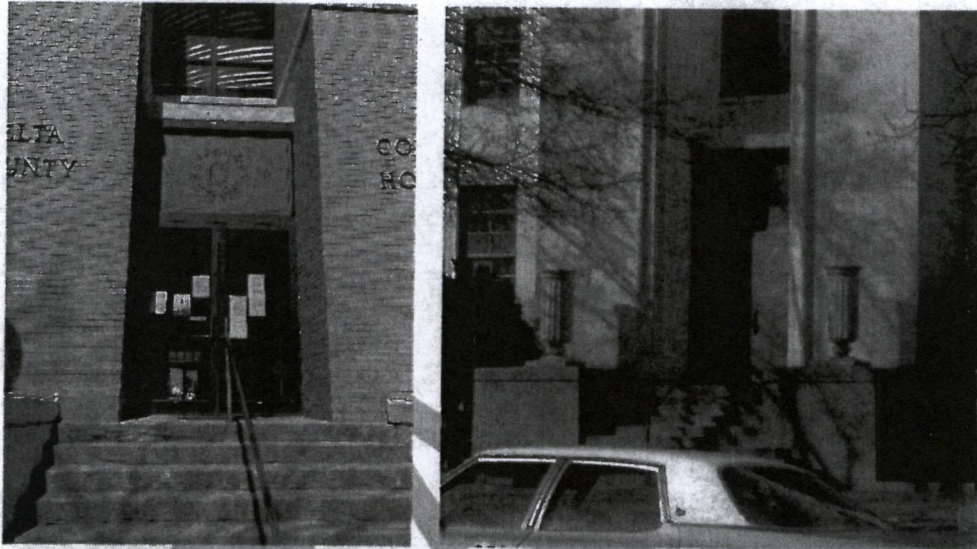
replacement doors have the same proportions but are a dark bronze colored aluminum with full height glass panes and a large transom window with the County seal etched into it at the north, south, and east doors. The replacement doors are in fair to good condition; however, they removed a significant Art Deco character defining feature of the original courthouse design. The masonry lintel at the east entrance is in severe condition. Cracks have turned into spalls and there is a loss of material. The west facing door is a single hollow metal door with a small vision panel. The finish is worn, and rust is visible. The door is in poor condition.

Left: Example of replacement doors at south entrance. Right: View of original solid doors.

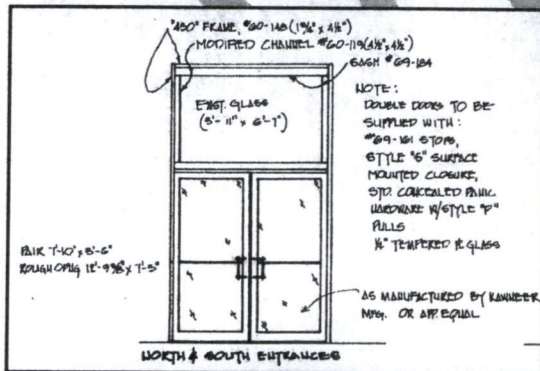
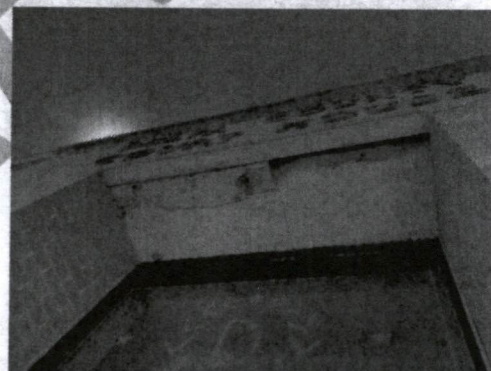
Left: Clip of construction documents from 1977 exterior renovation. Right: View of deteriorated lintel at east door.

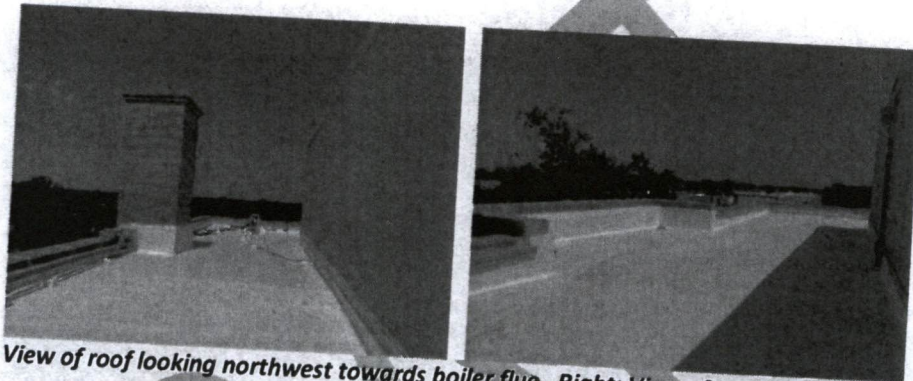
The roof was recently replaced as a self-funded emergency repair by the County in August 2023. The new roof material is a fully adhered Carlisle 80 mil TPO Roof Assembly per the 2023 bid documents. Poor drainage and standing water have plagued the Courthouse for many years. The black and white image below is from 1990 and large areas of ponding water are visible. Ponding water such as this can add a significant amount of weight which can damage the underlying structure. Komatsu was not able to inspect the concrete roof deck from above prior to the replacement, but cracks and other deterioration are visible at the roof deck from the third floor. A structural engineer must review to confirm the structural integrity. Only two roof drains exist, one at each of the north and south facing projections. The flat roof is crickets towards the drain. Overflow drains and/or scuppers are not present.

Left: View of roof looking northwest towards boiler flue. Right: View of roof looking northeast.

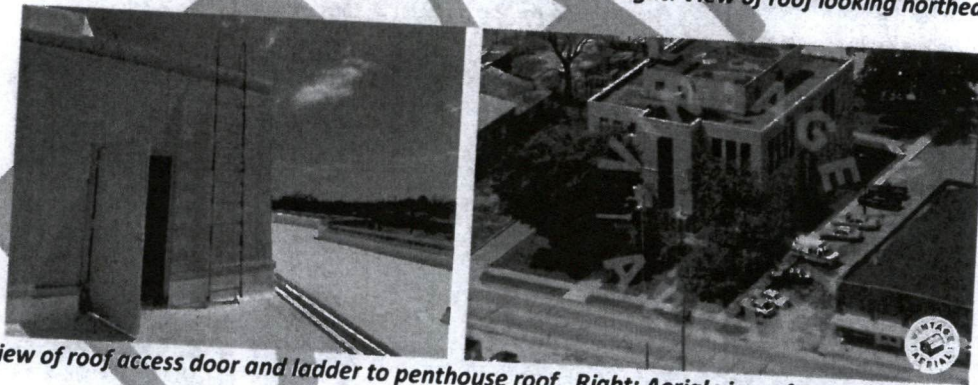
Left: View of roof access door and ladder to penthouse roof. Right: Aerial view of Courthouse, circa 1990.

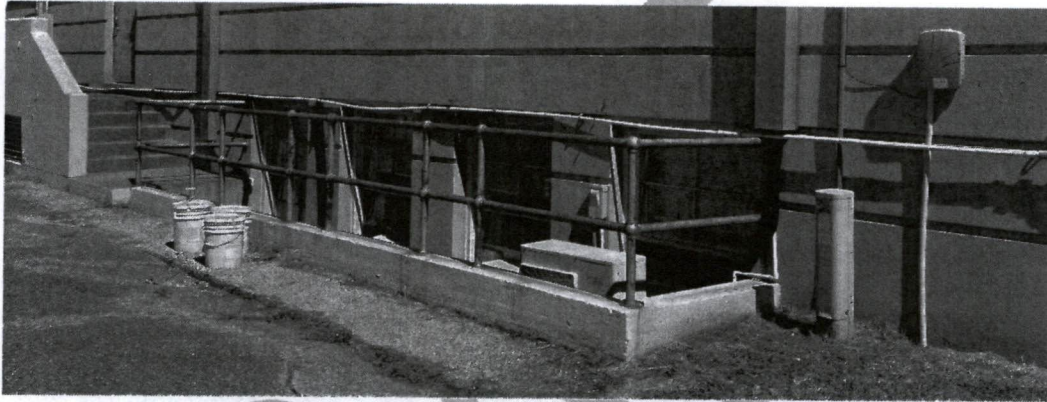
At the west elevation, pipe guide rails are present. Their detail and materiality align with the Courthouse's construction date. They are in poor condition as their coating has worn away and rust and corrosion are present throughout. In general, the areaways are in poor to fair condition. The drains should be scoped to review their condition.

Extant pipe railing at west facing areaway.

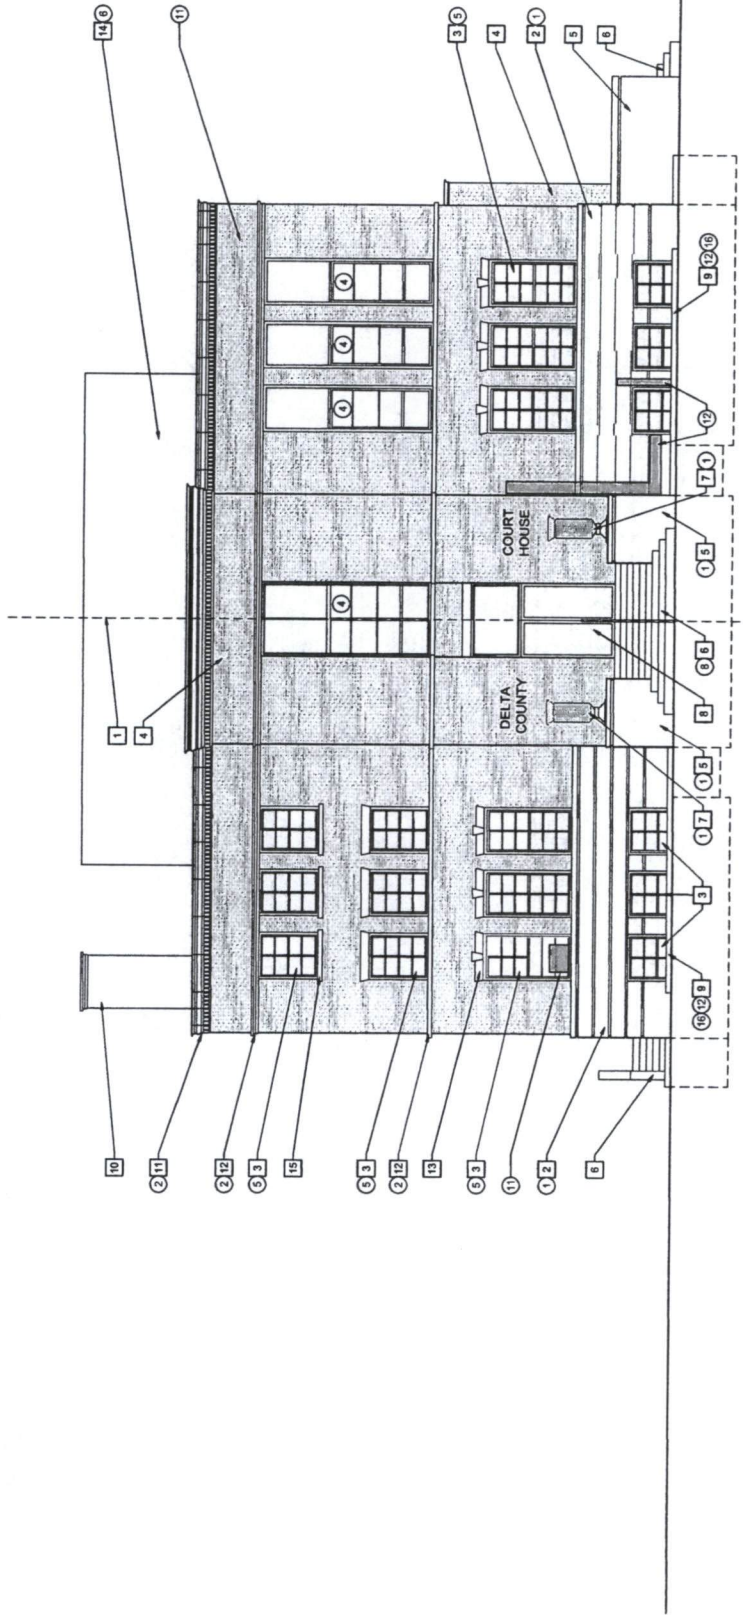
SOUTH ASSESSMENT ELEVATION
 NOT FOR REGULATORY APPROVAL, PERMITTING, OR CONSTRUCTION

- DEFICIENCY NOTES BY SYMBOL "D"**
1. PAINTED CAST STONE SURFACE
 - a. PEELING PAINT AT CAST STONE SURFACE
 - b. PEELING PAINT AT SOFFIT
 2. STAINING AT CAST STONE ELEMENT, TYP.
 3. CRACKING AT CAST STONE ELEMENT
 4. INTRUSIVE ALUMINUM WINDOW
 5. DETERIORATED WOOD WINDOW, TYP.
 6. INFILLED OR COVERED WINDOW
 7. DETERIORATED MASONRY LINTEL
 8. INTRUSIVE COATING AT CONCRETE STEPS
 9. NON-ADA COMPLIANT HANDRAIL
 - a. NO HANDRAIL

10. INTRUSIVE, DETERIORATED METAL RAMP
11. HVAC WINDOW UNIT AND CONDENSATE DRIP STAINING
12. INTRUSIVE MEP EQUIPMENT, CONDUIT, OR METAL SHEATHING, ETC.
13. CORROSION AT GUARDRAIL
14. DETERIORATED DOOR
15. NO EXTERIOR LIGHTING
16. DRAINAGE ISSUES AT LIGHT WELLS
17. CONCRETE STEPS CRACKING AND WHITE STAINING

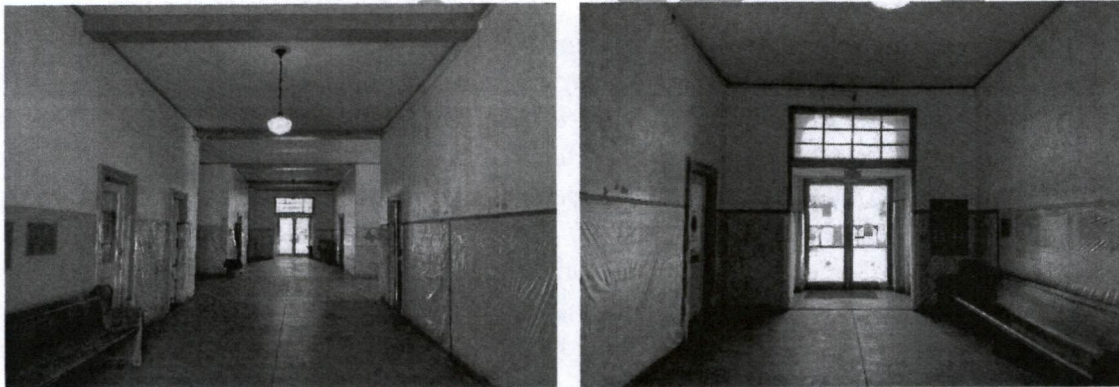
exposed beams. Some patching is visible at the east to west oriented ceiling. Intrusive wire mold is also present where cameras have been added. In general, the ceiling is in good condition. During the development of this report, the County undertook a painting project at the central corridor walls and ceiling under the advisement of the THC.

*Left: Central Corridor looking north. Right: Central Corridor looking south
Note: plastic covering wainscot was for active paint project.*

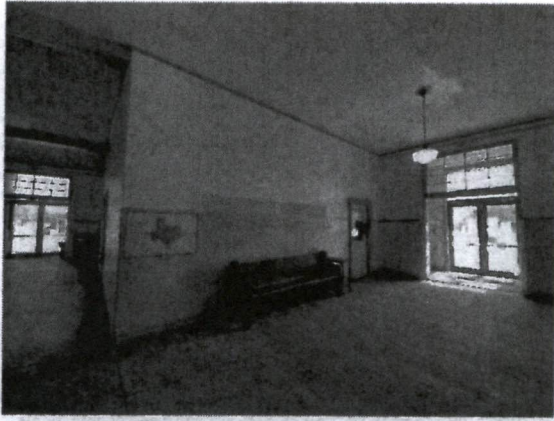
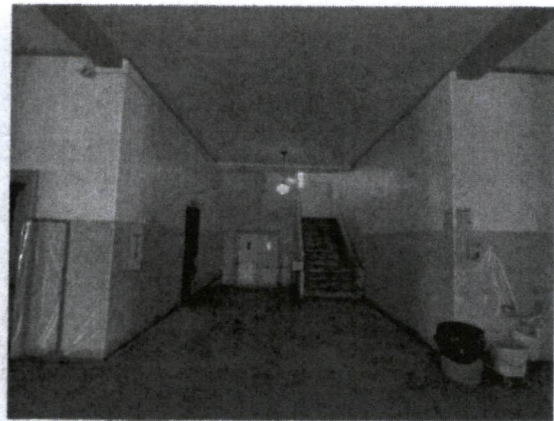
Left: Central Corridor looking northeast. Right: Central Corridor looking west towards main staircase on right and elevator door on left. Note: plastic covering wainscot was for active paint project.

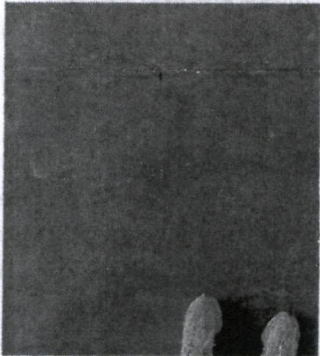
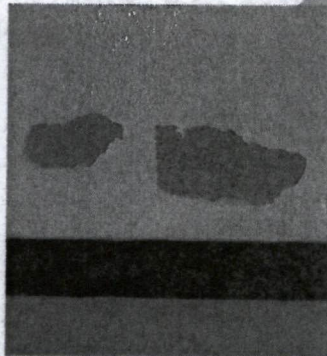
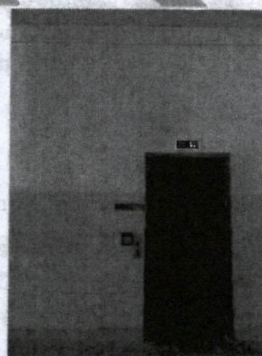
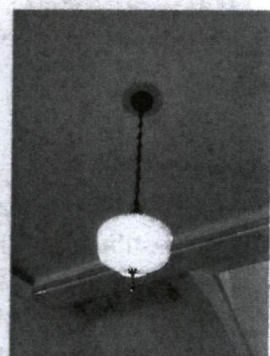
The first-floor corridor is laid out in a cruciform shape that aligns with the entry doors in each cardinal direction. The corridor's appearance and finish materials are characteristic of the early 1940s. The existing floor finish is polished concrete. Prior to the start of this assessment, the County removed a severely deteriorated tile finish and several paint coatings down to bare concrete and added a new clear coat. The tile was buckling, which caused a trip hazard at the entrances. Komatsu did not observe the floor tile in person, but the tile visible in photographs appears to be intrusive by size and color. It is unclear if the concrete was the original finish. The original floor plans do not provide much detail, however, a floor tile hatch pattern is visible. The concrete coloring is uneven, but overall, the floor is in fair condition.

Four schoolhouse globe pendant light fixtures exist at the first-floor corridor. These appear to be original and in good condition. The County has currently received funding to upgrade these fixtures to an LED light source while maintaining the historic appearance.

Left: Example of current concrete floor condition. Left Center: Sanded plaster texture revealed behind layers of paint. Right Center: New light green paint color and view of tile wainscot uncovered. Right: Example of original light fixture at corridor.

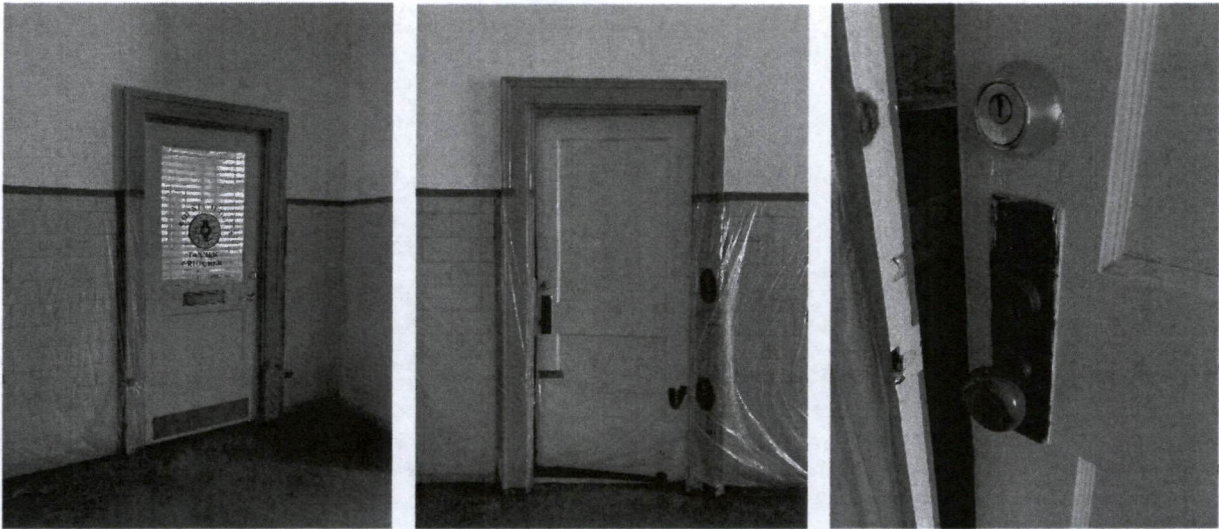
Original wood office doors remain throughout the corridor along with their decorative trim work. Most have been modified with new handles and locks. All office doors have a glass pane at the upper half of the door leaf. All office signage appears to be contemporary. The doors range in fair to good shape. The hardware condition ranges from poor to fair.

Left: Example of office door with glass. Center: Example of solid door at storage. Right: Example of original door knob and decorative face plate.

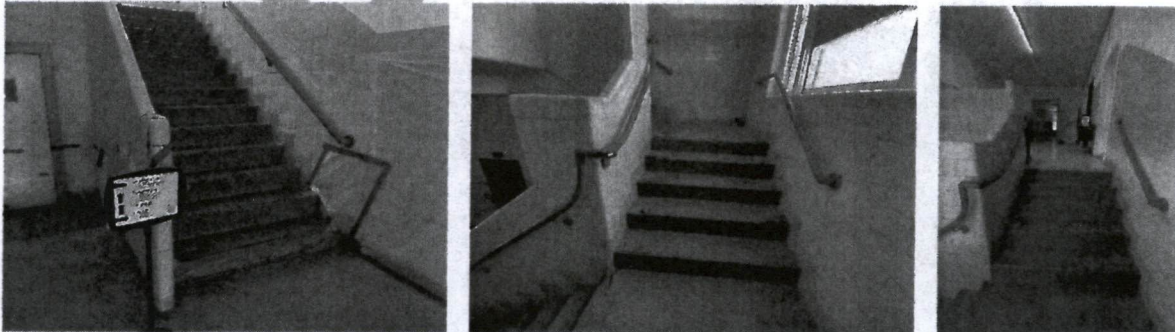
The Central Stairs only extend from the first floor to the second floor. Upper and lower floors are accessed from secondary staircases. The Central Stairs are cast-in-place concrete with a painted coating. The same tile wainscot wraps both sides of the stair and ends at the second-floor landing. Most of the deficiencies are the stairs are superficial. The paint coating is worn. The adhesive edge grips are peeling off. Minor hairline cracks are visible, which is typical of this type of concrete due to shrinkage from initial drying. The most significant deficiency is that the handrails do not meet current TAS requirements.

Left: Central Stair at first floor. Center: Central Stair at intermediate landing. Right: Central Stair looking towards second floor.

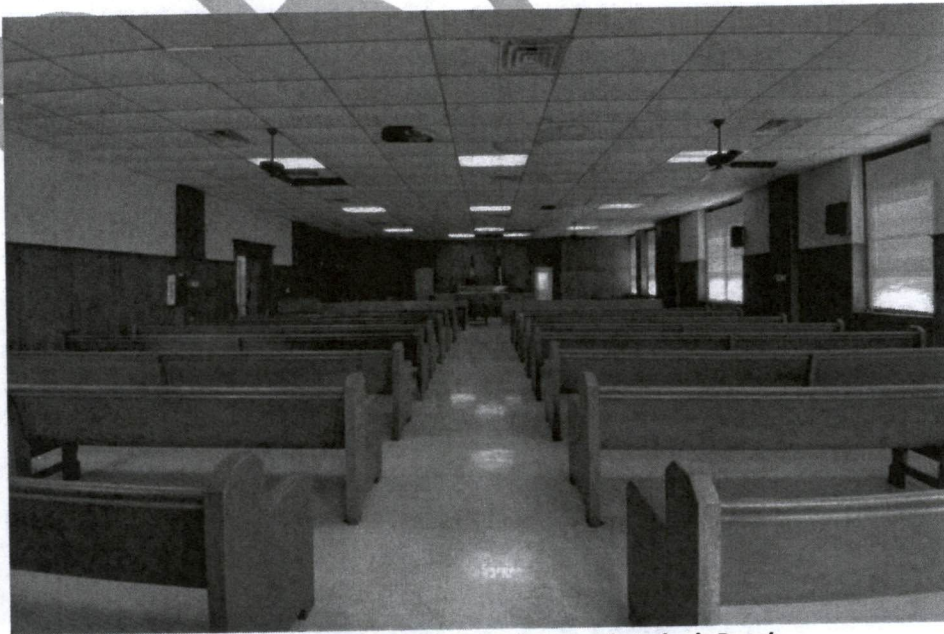
The most significant deficiency in the District Courtroom was a major leak over the Judge's Bench area. This area is directly below the roof leak that has affected the third floor. The leak has caused damage at the suspended grid ceiling, as well as the Judge's Bench and platform it sits on. The original plaster ceiling is visible above the grid ceiling. Water damage was visible, but the overall condition of the original ceiling is unknown. Other leaks are visible at other acoustical tiles throughout the space.

District Courtroom looking north towards Judge's Bench.

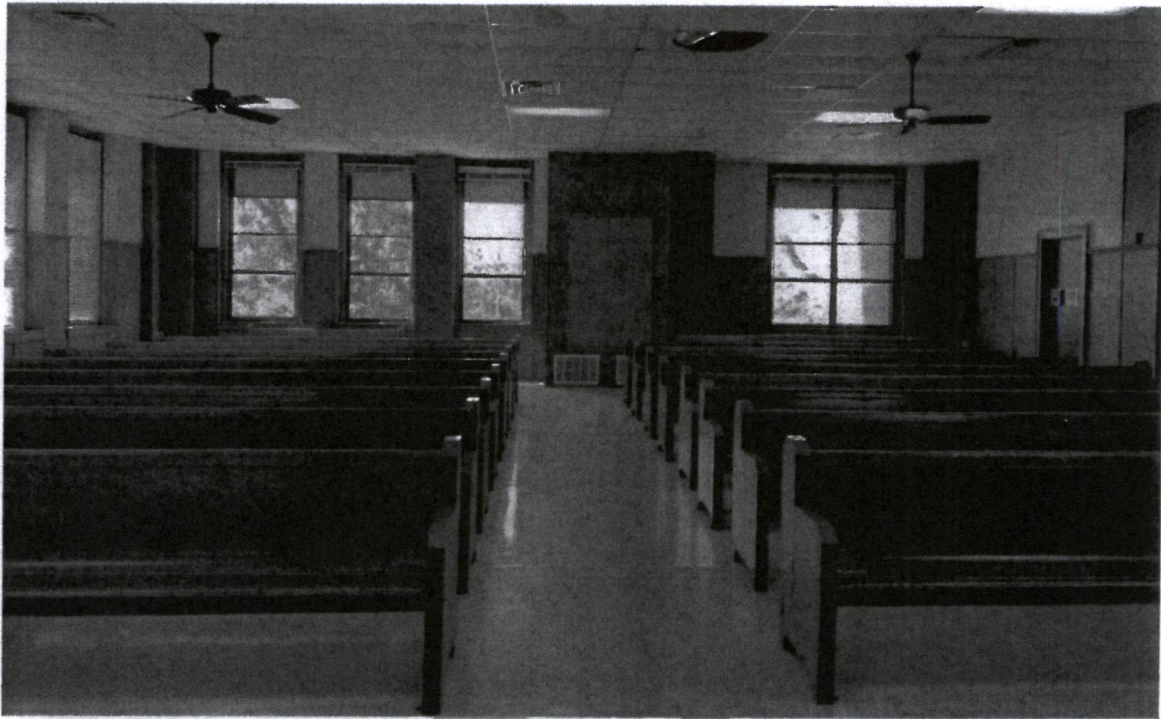
District Courtroom looking south.

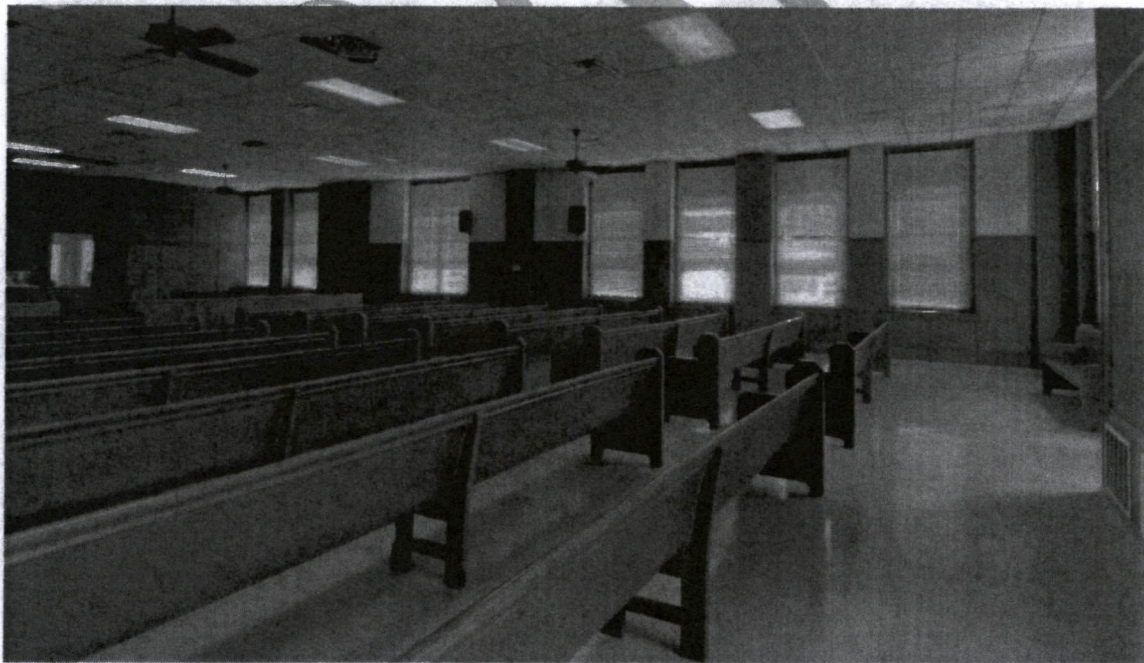
District Courtroom looking east.

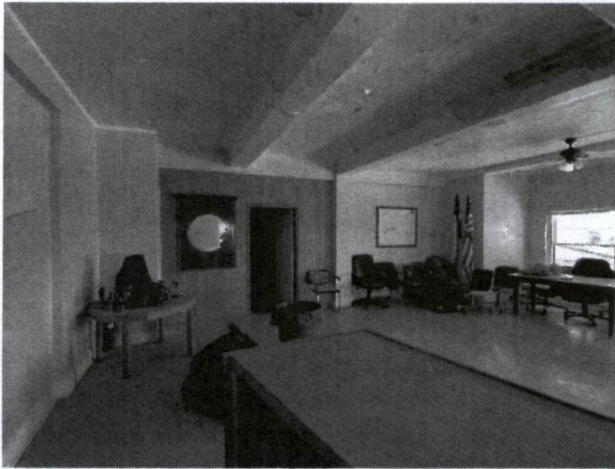
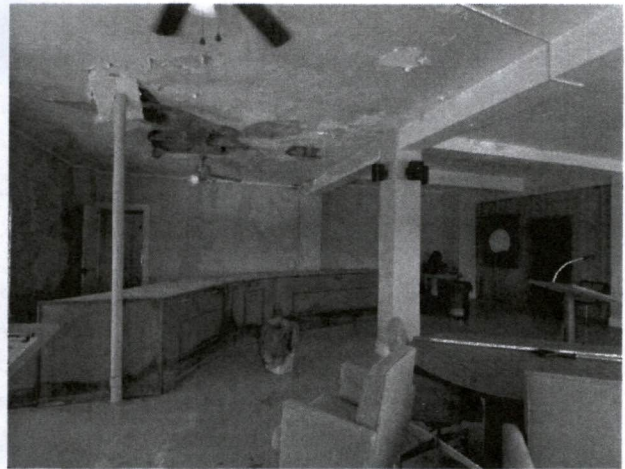
The County Courtroom has been the most affected by the severe condition of the roof and ongoing roof leaks. The floor is exposed concrete with several paint coatings. The concrete is in fair condition; however, the coatings are in poor to severe condition. Water leaks have compromised the plaster walls at the east and north walls. Contemporary paint coatings are peeling, revealing early paint layers. The plaster is spalling and damaged in several locations. The ceiling is suspended plaster. The roof leak has caused a major plaster spall directly over the Commissioners Court Dias. The metal lathe is rusted and corroded. Metal rebar is also visible at the concrete elements, and it appears rusted as well. The ceiling structure changes at the central beam line that runs east to west across the middle of the roof. The northern portion appears to be a two-way waffle slab, while the southern portion is a one-way slab with cast in place beams. Several major cracks are visible in the concrete roof deck, most likely due to the weight of the water that sat on the roof.

Left: View of County Courtroom looking south. Right: View of County Courtroom looking east.

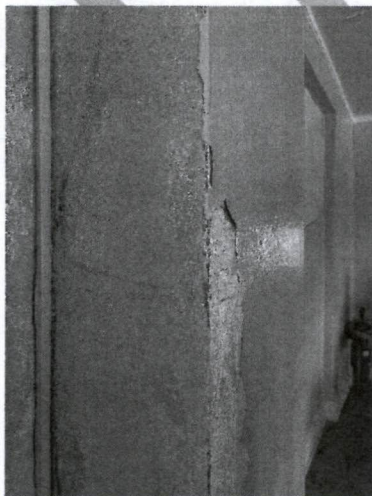
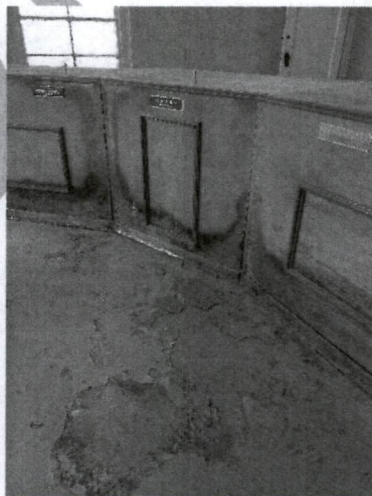
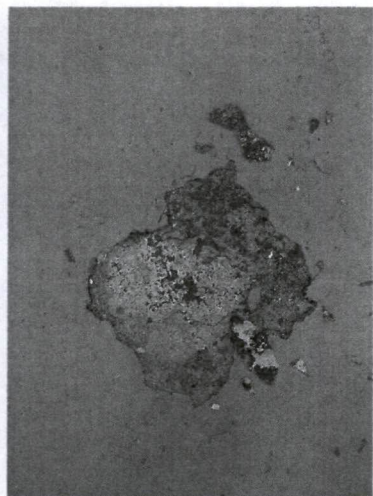
Mini split HVAC units have been added to the west and north walls. The Commissioners Court Dias is a complete loss. The roof leaks has caused severe water damage at all sides of the Dias.

Left: Close up of original paint layers behind spalled contemporary layers. Center: View of water damage at Dias and concrete floor. Right: Close up of paint layers at concrete floor.

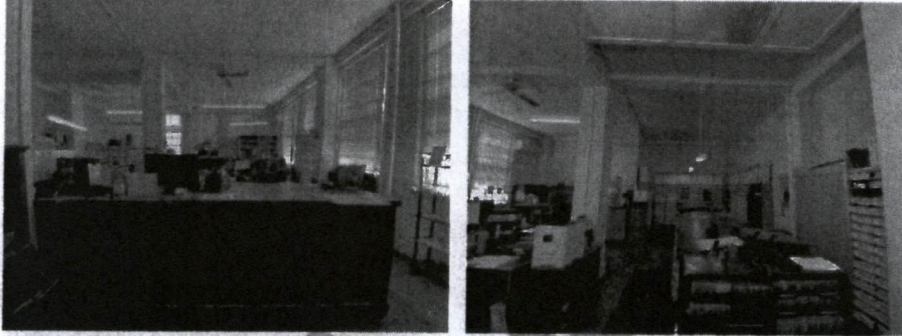
County / District Clerk's Office

Most offices have received alterations and modifications by their elected officials through the years. The major finishes are intact. The floors are concrete with several intrusive paint coatings. The main walls are plaster and all exposed structural elements are covered in a plaster coating. The ceilings are suspended plaster between plaster coated beams. All extant features and materials exhibit general wear and are in fair condition with some localized areas in poor condition. Most light fixtures have been replaced. The images below illustrate the conditions at several office spaces.

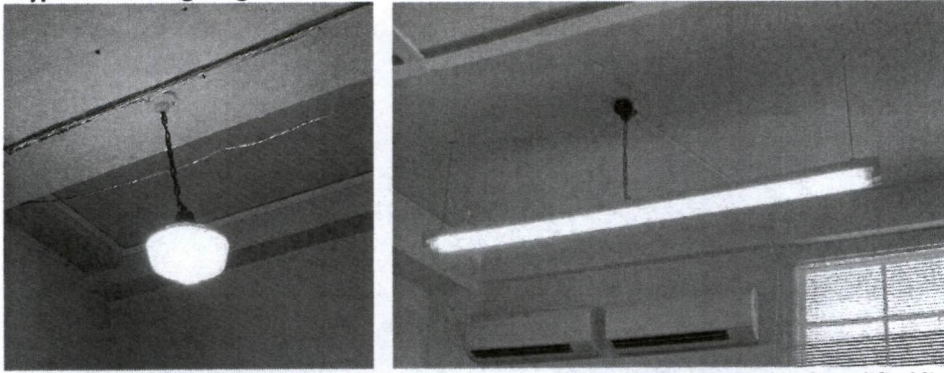
Typical Office Lighting

Left: Example of original schoolhouse fixture in Tax Assessor's office. Right: Example of modified light fixture at County/District Clerk's office with original escutcheon plate and chain with contemporary fluorescent tube bulbs.

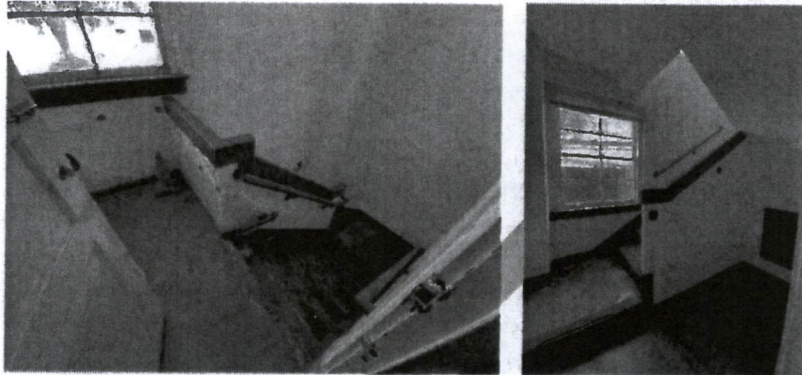
The North Stair clear width is 40", which should satisfy code requirements as it is a second means of egress. The handrails do not meet code as they lack the required extensions. During the assessment, the County was working on refreshing the paint coatings at the treads and landings that have worn through.

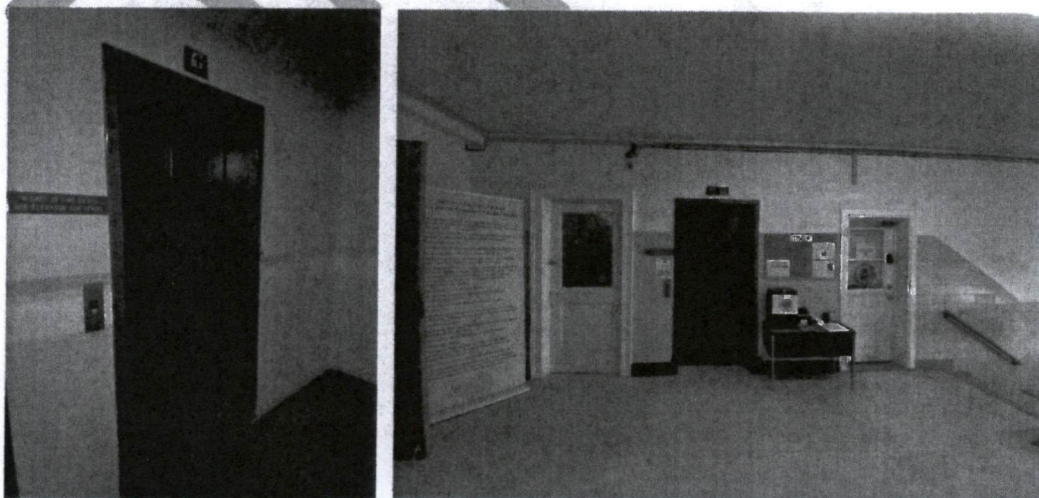
The existing elevator was constructed in 1986, however, it only serviced the basement through third floors. In the late 1990s, the elevator shaft was extended to reach the fourth floor. The elevator is in operational order, technically. However, the County has experienced over six entrapments over the last few years. Even the elevator repair technician has been stuck inside. The elevator company has indicated that the cab and mechanisms are reaching the end of their service life. Replacement parts are getting harder to come by. Two fires have occurred in the elevator control room at the fourth floor due to an electrical shortage. With the elevator out of service multiple times a year, the County cannot properly serve its constituents or hold proceedings in the District Courtroom. Replacing the elevator is a critical need for the County.

Left: View of elevator door at basement. Right: View of elevator door at second floor.

The County would like to reuse the elevator shaft if possible and replace the existing cab and mechanism. The existing cab platform size does not meet TAS requirements, and the size of the shaft is too narrow to accommodate the larger TAS complaint size. TAS has an "existing elevator" exception under Section 407.4.1:

TAS noted that reusing the existing shaft would fall under this exception via email. This item should be investigated further during construction document development to ensure that a new cab can be fabricated to meet this requirement as well as the cost implications.

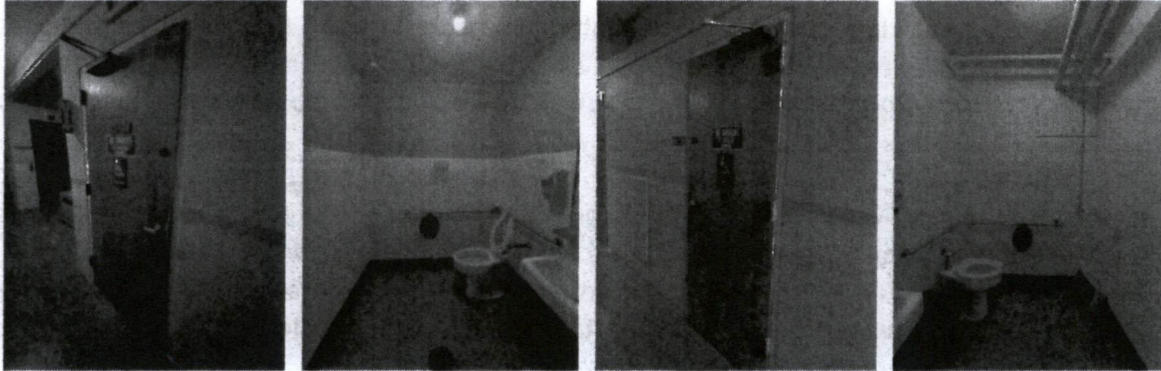
Basement Accessible Men's and Women's Restroom

The main public restrooms are located in the basement and at the second floor. The basement restrooms include both gang restrooms and single user restrooms. The gang restrooms have been permanently closed by the County due to the severe condition of the fixtures and plumbing. The basement single user restrooms are in fair condition. They appear to meet current TAS requirements. However, the elevator has been down regularly, which limits access. The basement restrooms also lack exhaust ventilation and hot water.

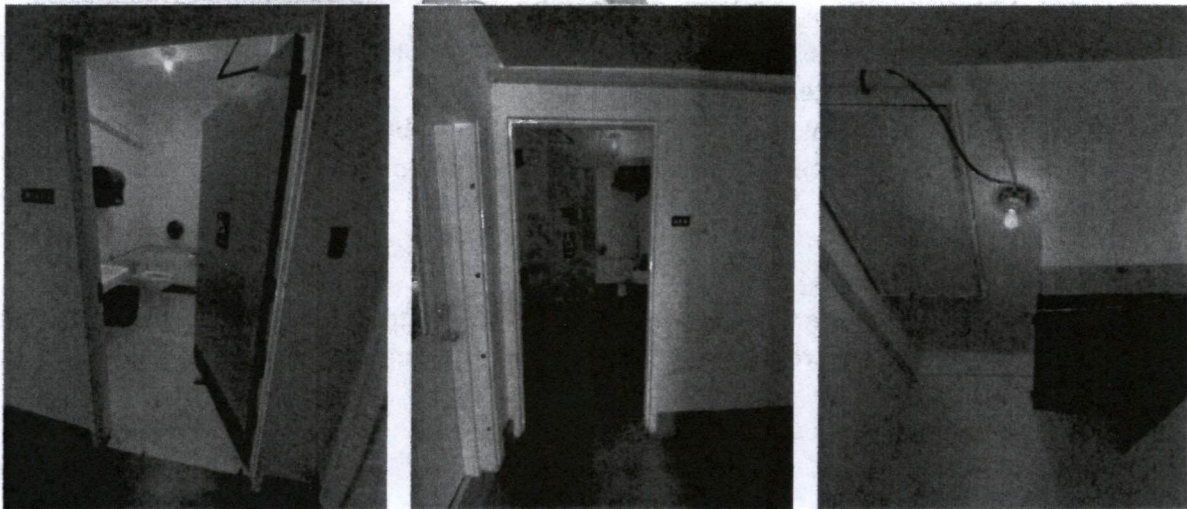
Second Floor Accessible Restrooms

The second-floor restrooms are also accessible single users. They are only accessible from the public courtroom through the District Courtroom. The restrooms appear to meet TAS requirements. The finishes are in fair to poor condition. The ceiling at the Men's restroom has a makeshift access panel out of plywood that is warped.
