NOTICE OF REGULAR MEETING
DELTA COUNTY COMMISSIONERS COURT

This report fulfills the Texas Historical Commission's requirements outlined in the "Recommended Outline for a Courthouse Preservation Master Plan".

Summary of Existing Conditions & Recommendations

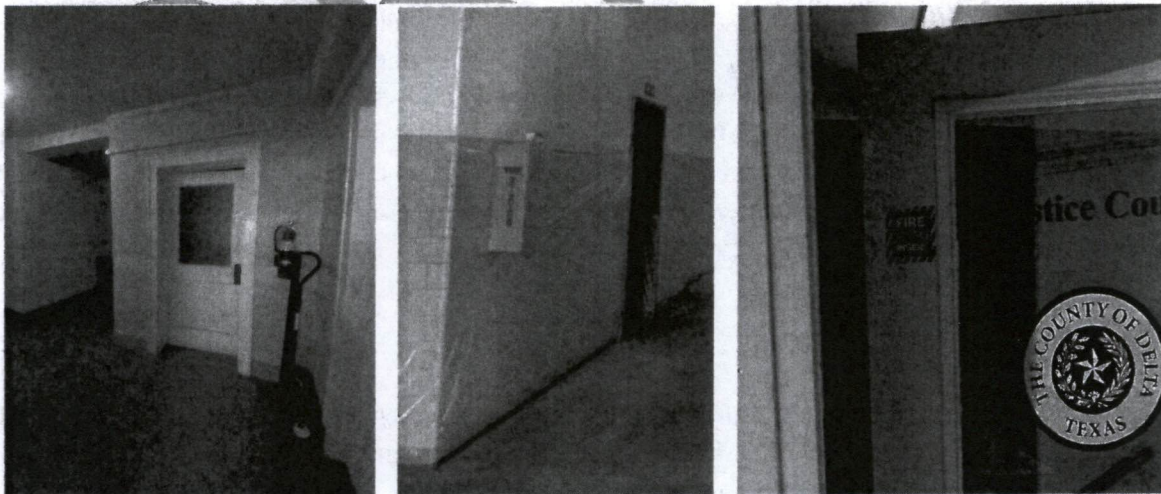
The Courthouse is missing most life safety measures required by code. Exit signage is present at the first-floor entrances. Fire extinguishers were visible throughout the building. The extinguishers at the basement do not have cabinets. One was sitting on the floor. The fire extinguishers at the second floor are stored in offices with notifications on the office doors. However, fire extinguishers were not present at the upper floors. The building is not outfitted with smoke detectors, fire alarms, or an automatic sprinkler system.

Left: Fire extinguisher at basement level. Center: Fire extinguisher cabinet at first floor corridor. Right: Sticker at Justice of the Peace’s office door indicating a fire extinguisher within.
